Access Compliance Report

Public Rights-of-Way

(Curb Ramps)

Intersection ID: 16060	Main Street: MARSH_RD	Cross Street: MELBOURNE_CT	Location: SW
ADA ID: 2875ED4CDEC5	Ramp Type: BlendTrans1	Initial Pass/Fail: Fail	Overall Compliance: No
Severity Score: 1.25			
Codes/Mitigation Info/Possible Solution		Field Measurements/Component Compliance

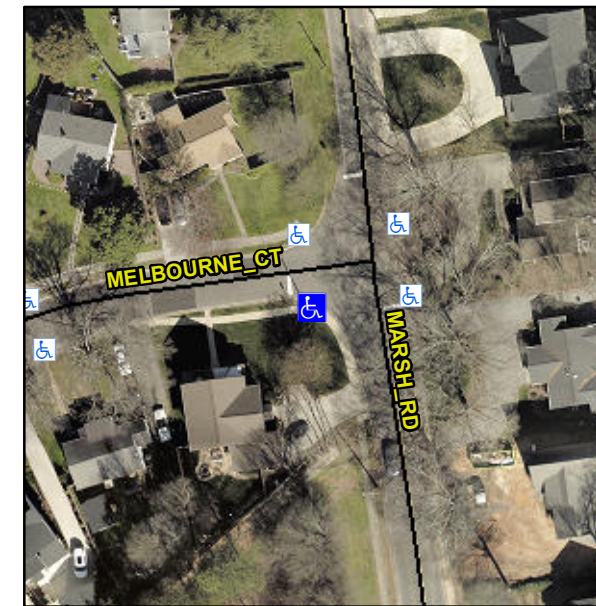
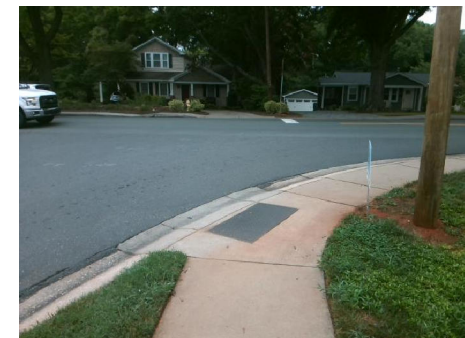
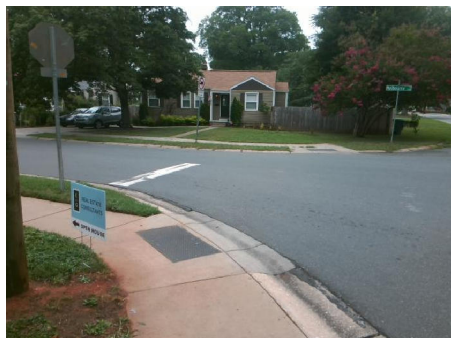
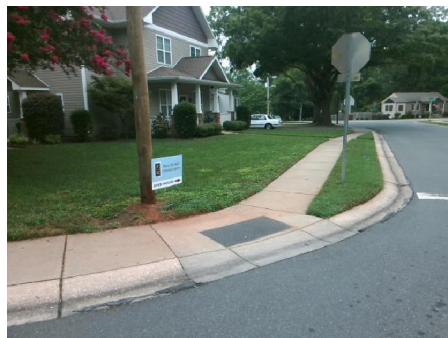
Not Found, R304.5.3

Compliance	Description	Data	Compliance	Description	Data
N/A	Ramp Length (in)	26.0	Yes	BlendTrans Slope (%)	4.1
Yes	Ramp Width (in)	48.0	No	BlendTrans XSlope (%)	3.1
N/A	Flare Type LT	N/A	N/A	Flare Type RT	N/A
N/A	Flare Slope LT (%)	N/A	N/A	Flare Slope RT (%)	N/A
N/A	Flare Traversable LT?	N/A	N/A	Flare Traversable RT?	N/A
N/A	Landing Length (in)	N/A	N/A	DWS Provided?	N/A
N/A	Landing Width (in)	N/A	N/A	DWS Contrast?	N/A
N/A	Landing Slope (%)	N/A	N/A	DWS Length (in)	N/A
N/A	Landing X Slope (%)	N/A	N/A	DWS Full Width?	N/A
N/A	Landing Curb? (Y/N)	N/A	N/A	DWS Offset (in)	N/A
N/A	Shared Landing?	N/A			
N/A	Gutter Ponding?	N/A	N/A	Gutter Slope (%)	N/A
N/A	Gutter Lip Ht (in)	N/A	N/A	Gutter X Slope (%)	N/A
N/A	Painted X Walk1?	No	N/A	Painted X Walk2?	No
	X Walk 1 Direction	To E		X Walk 2 Direction	To N
	X Walk 1 Width (in)	N/A		X Walk 2 Width (in)	N/A
	X Walk 1 Slope (%)	3.4		X Walk 2 Slope (%)	2.4
	X Walk 1 X Slope (%)	0.1		X Walk 2 X Slope (%)	3.6

N/A	Ramp inside XWalk1?	N/A	N/A	Ramp inside XWalk2?	N/A
	Road Slope (%)	2.1		Clear Space?	N/A
	Road X Slope (%)	4.5	N/A	Clear Space to XWalk (in)	N/A
N/A	Any Obstructions?	N/A	N/A	Storm Grate/Utility Hazard?	N/A
	Obstruction Type			Storm Grate/Utility Type	
		N/A			N/A
			Yes	Surface Condition? (G/P)	Good
			No	Curb Slope (%)	21.8

Remove & Replace Curb Ramp With Two New Directional Ramps or Equivalent.
