Access Compliance Report

Public Rights-of-Way

(Curb Ramps)

Intersection ID: 7452	Main Street: N_HOSKINS_RD	Cross Street: BEATTIES_FORD_RD	Location: SW
ADA ID: 2877D3BBC5D5	Ramp Type: PerpDiag	Initial Pass/Fail: Fail	Overall Compliance: No
		Severity Score: 12.5

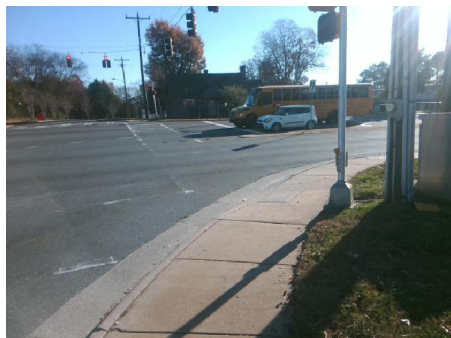
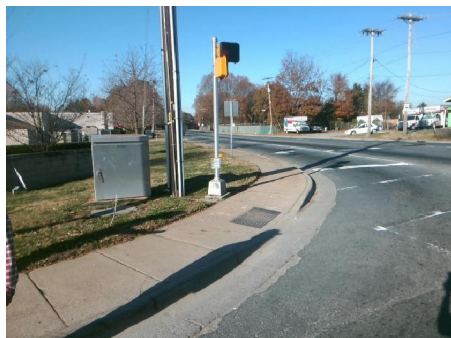
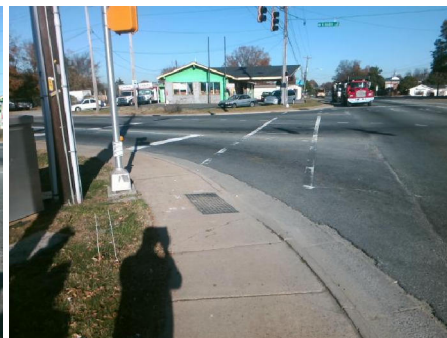
Not Found, R304.2.2

Compliance	Description	Data	Compliance	Description	Data
N/A	Ramp Length (in)	60.0	No	Ramp Slope (%)	10.8
Yes	Ramp Width (in)	52.0	Yes	Ramp XSlope (%)	1.1
N/A	Flare Type LT	N/A	N/A	Flare Type RT	N/A
N/A	Flare Slope LT (%)	N/A	N/A	Flare Slope RT (%)	N/A
N/A	Flare Traversable LT?	N/A	N/A	Flare Traversable RT?	N/A
N/A	Landing Length (in)	N/A	N/A	DWS Provided?	N/A
N/A	Landing Width (in)	N/A	N/A	DWS Contrast?	N/A
N/A	Landing Slope (%)	N/A	N/A	DWS Length (in)	N/A
N/A	Landing X Slope (%)	N/A	N/A	DWS Full Width?	N/A
N/A	Landing Curb? (Y/N)	N/A	N/A	DWS Offset (in)	N/A
N/A	Shared Landing?	N/A			
N/A	Gutter Ponding?	N/A	N/A	Gutter Slope (%)	N/A
N/A	Gutter Lip Ht (in)	N/A	N/A	Gutter X Slope (%)	N/A
N/A	Painted X Walk1?	No	N/A	Painted X Walk2?	No
	X Walk 1 Direction	To E		X Walk 2 Direction	To N
N/A	X Walk 1 Width (in)	N/A	N/A	X Walk 2 Width (in)	N/A
	X Walk 1 Slope (%)	0.2		X Walk 2 Slope (%)	1.5
	X Walk 1 X Slope (%)	0.0		X Walk 2 X Slope (%)	1.1

N/A	Ramp inside XWalk1?	N/A	N/A	Ramp inside XWalk2?	N/A
	Road Slope (%)	0.3	N/A	Clear Space?	N/A
	Road X Slope (%)	1.0	N/A	Clear Space to XWalk (in)	N/A
N/A	Any Obstructions?	N/A	N/A	Storm Grate/Utility Hazard?	N/A
	Obstruction Type			Storm Grate/Utility Type	
		N/A			N/A
		Yes		Surface Condition? (G/P)	Good

Possible Solutions:

Remove & Replace Curb Ramp With Two New Directional Ramps or Equivalent.
