Access Compliance Report

Public Rights-of-Way

(Curb Ramps)

Intersection ID: 29264	Main Street: SEEDLING_LN	Cross Street: WOODINGTON_LN	Location: E
ADA ID: 28848627A0EE	Ramp Type: PerpDiag	Initial Pass/Fail: Fail	Overall Compliance: No
Severity Score: 46.25			
Codes/Mitigation Info/Possible Solution		Field Measurements/Component Compliance

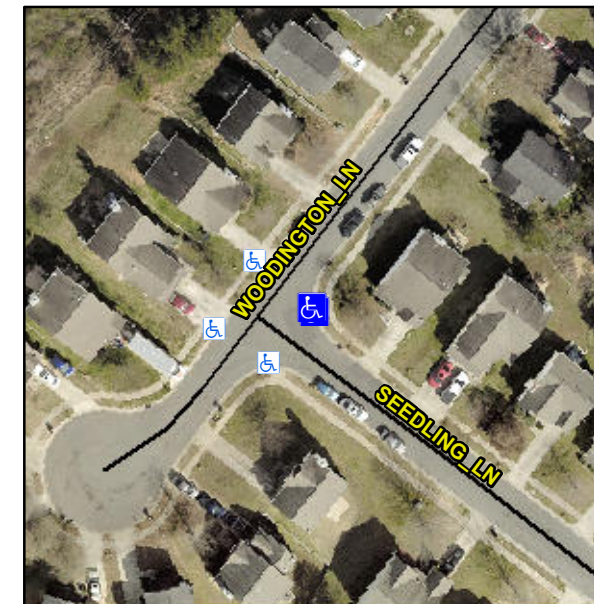
Not Found, R304.5.1, R304.2.2, R304.5.3

Compliance	Description	Data	Compliance	Description	Data
N/A	Ramp Length (in)	48.0	No	Ramp Slope (%)	11.5
No	Ramp Width (in)	43.0	No	Ramp XSlope (%)	12.4
N/A	Flare Type LT	N/A	N/A	Flare Type RT	N/A
N/A	Flare Slope LT (%)	N/A	N/A	Flare Slope RT (%)	N/A
N/A	Flare Traversable LT?	N/A	N/A	Flare Traversable RT?	N/A
N/A	Landing Length (in)	N/A	N/A	DWS Provided?	N/A
N/A	Landing Width (in)	N/A	N/A	DWS Contrast?	N/A
N/A	Landing Slope (%)	N/A	N/A	DWS Length (in)	N/A
N/A	Landing X Slope (%)	N/A	N/A	DWS Full Width?	N/A
N/A	Landing Curb? (Y/N)	N/A	N/A	DWS Offset (in)	N/A
N/A	Shared Landing?	N/A			
N/A	Gutter Ponding?	N/A	N/A	Gutter Slope (%)	N/A
N/A	Gutter Lip Ht (in)	N/A	N/A	Gutter X Slope (%)	N/A
N/A	Painted X Walk1?	No	N/A	Painted X Walk2?	No
	X Walk 1 Direction	To NW		X Walk 2 Direction	To SW
N/A	X Walk 1 Width (in)	N/A	N/A	X Walk 2 Width (in)	N/A
	X Walk 1 Slope (%)	0.6		X Walk 2 Slope (%)	4.3
	X Walk 1 X Slope (%)	9.9		X Walk 2 X Slope (%)	0.6

N/A	Ramp inside XWalk1?	N/A	N/A	Ramp inside XWalk2?	N/A
	Road Slope (%)	6.2	N/A	Clear Space?	N/A
	Road X Slope (%)	6.9	N/A	Clear Space to XWalk (in)	N/A
N/A	Any Obstructions?	N/A	N/A	Storm Grate/Utility Hazard?	N/A
	Obstruction Type			Storm Grate/Utility Type	
		N/A			N/A
			Yes	Surface Condition? (G/P)	Good

Possible Solutions:

Remove & Replace Curb Ramp With Two New Directional Ramps or Equivalent.
