# Access Compliance Report

## Public Rights-of-Way

### (Curb Ramps)

Intersection ID: N/A	Main Street: GANNON_DR	Cross Street: RACHEL_FREEMAN_WY	Location: SW
ADA ID: 288685C8CC0D	Ramp Type: Perp	Initial Pass/Fail: Fail	Overall Compliance: No
Severity Score: 12.5			
Codes/Mitigation Info/Possible Solution		Field Measurements/Component Compliance

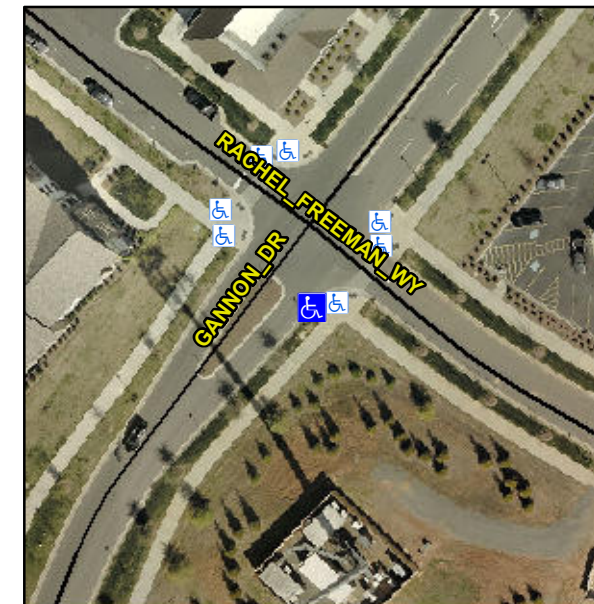
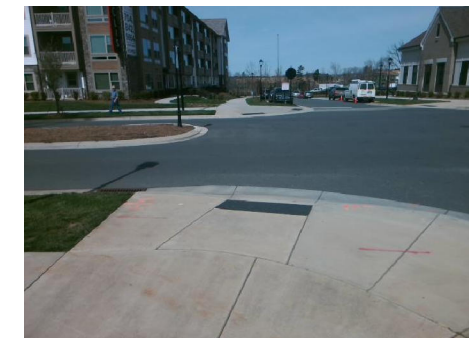
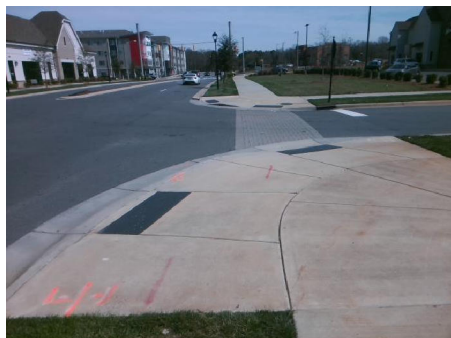
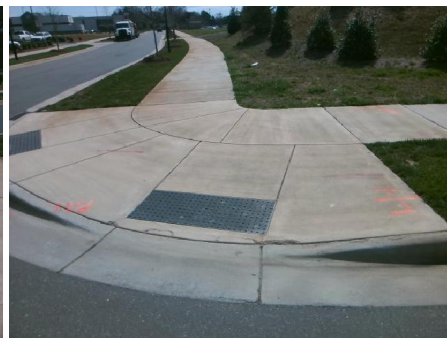
**Not Found, R304.2.2**

Compliance	Description	Data	Compliance	Description	Data
N/A	Ramp Length (in)	94.0	No	Ramp Slope (%)	9.6
Yes	Ramp Width (in)	60.0	Yes	Ramp XSlope (%)	0.9
N/A	Flare Type LT	N/A	N/A	Flare Type RT	N/A
N/A	Flare Slope LT (%)	N/A	N/A	Flare Slope RT (%)	N/A
N/A	Flare Traversable LT?	N/A	N/A	Flare Traversable RT?	N/A
N/A	Landing Length (in)	N/A	N/A	DWS Provided?	N/A
N/A	Landing Width (in)	N/A	N/A	DWS Contrast?	N/A
N/A	Landing Slope (%)	N/A	N/A	DWS Length (in)	N/A
N/A	Landing X Slope (%)	N/A	N/A	DWS Full Width?	N/A
N/A	Landing Curb? (Y/N)	N/A	N/A	DWS Offset (in)	N/A
N/A	Shared Landing?	N/A			
N/A	Gutter Ponding?	N/A	N/A	Gutter Slope (%)	N/A
N/A	Gutter Lip Ht (in)	N/A	N/A	Gutter X Slope (%)	N/A
N/A	Painted X Walk1?	No	N/A	Painted X Walk2?	N/A
	X Walk 1 Direction	To NW		X Walk 2 Direction	N/A
N/A	X Walk 1 Width (in)	N/A	N/A	X Walk 2 Width (in)	N/A
	X Walk 1 Slope (%)	3.8		X Walk 2 Slope (%)	N/A
	X Walk 1 X Slope (%)	1.3		X Walk 2 X Slope (%)	N/A

N/A	Ramp inside XWalk1?	N/A	N/A	Ramp inside XWalk2?	N/A
	Road Slope (%)	N/A	N/A	Clear Space?	N/A
	Road X Slope (%)	N/A	N/A	Clear Space to XWalk (in)	N/A
N/A	Any Obstructions?	N/A	N/A	Storm Grate/Utility Hazard?	N/A
	Obstruction Type			Storm Grate/Utility Type	
		N/A			N/A
		Yes		Surface Condition? (G/P)	Good

**Remove & Replace Entire Ramp.**
