Access Compliance Report Public Rights-of-Way (Curb Ramps)

Intersection ID: 10026412 Main Street: FARM_POND_LN Cross Street: N/A Location: SW

ADA ID: 2888E6875890 Ramp Type: PerpDiag Initial Pass/Fail: Fail Overall Compliance: No Severity Score: 13.75

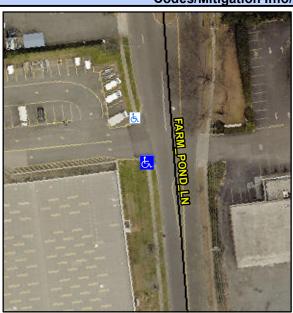
Field Measurements/Component Compliance						
	Compliance Description		Data	Comp	liance Description	Data
	N/A	Ramp Length (in)	35.0	No	Ramp Slope (%)	10.5
	Yes	Ramp Width (in)	48.0	Yes	Ramp XSlope (%)	2.5
	N/A	Flare Type LT	N/A	N/A	Flare Type RT	N/A
	N/A	Flare Slope LT (%)	N/A	N/A	Flare Slope RT (%)	N/A
	N/A	Flare Traversable LT?	N/A	N/A	Flare Traversable RT?	N/A
	N/A	Landing Length (in)	N/A	N/A	DWS Provided?	N/A
	N/A	Landing Width (in)	N/A	N/A	DWS Contrast?	N/A
	N/A	Landing Slope (%)	N/A	N/A	DWS Length (in)	N/A
	N/A	Landing X Slope (%)	N/A	N/A	DWS Full Width?	N/A
	N/A	Landing Curb? (Y/N)	N/A	N/A	DWS Offset (in)	N/A
	N/A	Shared Landing?	N/A			
	N/A	Gutter Ponding?	N/A	N/A	Gutter Slope (%)	N/A
	N/A	Gutter Lip Ht (in)	N/A	N/A	Gutter X Slope (%)	N/A
	N/A	Painted X Walk1?	No	N/A	Painted X Walk2?	No
		X Walk 1 Direction	To SE		X Walk 2 Direction	To N
	N/A	X Walk 1 Width (in)	N/A	N/A	X Walk 2 Width (in)	N/A
		X Walk 1 Slope (%)	5.7		X Walk 2 Slope (%)	2.2

X Walk 1 X Slope (%)	2.3		X Walk 2 X Slope (%)	1.1
	N/A	Ramp inside XWalk1?	N/A	N/A	Ramp inside XWalk2?	N/A
		Road Slope (%)	3.2	N/A	Clear Space?	N/A
		Road X Slope (%)	0.7	N/A	Clear Space to XWalk (in)	N/A
	N/A	Any Obstructions?	N/A	N/A	Storm Grate/Utility Hazard?	N/A
		Obstruction Type			Storm Grate/Utility Type	
			N/A			N/A
				Yes	Surface Condition? (G/P)	Good
		Add the same of th

Remove & Replace Curb Ramp With
Two New Directional Ramps or
Equivalent.
