# Access Compliance Report

## Public Rights-of-Way

### (Curb Ramps)

Intersection ID: N/A	Main Street: BANDY_DR	Cross Street: PENCE_RD	Location: SW
ADA ID: 288C8D3C433D	Ramp Type: Combination2Diag	Initial Pass/Fail: Fail	Overall Compliance: No
		Severity Score: 0

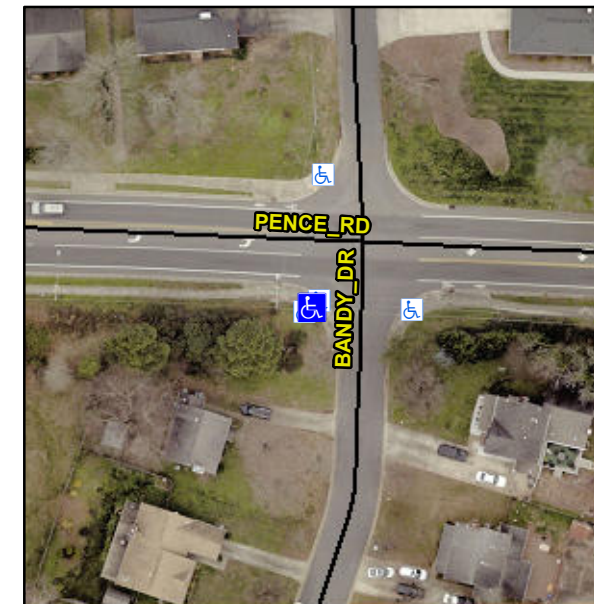
**Not Found, R304.5.1, R304.5.3, R304.3.2**

Compliance	Description	Data	Compliance	Description	Data
N/A	Ramp Length LT (in)	N/A	N/A	Ramp Length RT (in)	56.5
N/A	Ramp Width LT (in)	N/A	Yes	Ramp Width RT (in)	57.0
N/A	Ramp Slope LT (%)	N/A	No	Ramp Slope RT (%)	14.4
N/A	Ramp XSlope LT (%)	N/A	No	Ramp XSlope RT (%)	2.5
N/A	Ramp Length (in)	25.0	Yes	Ramp Slope (%)	3.3
No	Ramp Width (in)	40.0	No	Ramp XSlope (%)	5.5
N/A	Flare Type LT	N/A	N/A	Flare Type RT	N/A
N/A	Flare Slope LT (%)	N/A	N/A	Flare Slope RT (%)	N/A
N/A	Flare Traversable LT?	N/A	N/A	Flare Traversable RT?	N/A
N/A	Landing Length (in)	N/A	N/A	DWS Provided?	N/A
N/A	Landing Width (in)	N/A	N/A	DWS Contrast?	N/A
N/A	Landing Slope (%)	N/A	N/A	DWS Length (in)	N/A
N/A	Landing X Slope (%)	N/A	N/A	DWS Full Width?	N/A
N/A	Landing Curb? (Y/N)	N/A	N/A	DWS Offset (in)	N/A
N/A	Shared Landing?	N/A			
N/A	Gutter Ponding?	N/A	N/A	Gutter Slope (%)	N/A
N/A	Gutter Lip Ht (in)	N/A	N/A	Gutter X Slope (%)	N/A
N/A	Painted X Walk1?	No	N/A	Painted X Walk2?	No

X Walk 1 Direction	To E		X Walk 2 Direction	To N
	X Walk 1 Width (in)	N/A		X Walk 2 Width (in)	N/A
	X Walk 1 Slope (%)	0.5		X Walk 2 Slope (%)	3.9
	X Walk 1 X Slope (%)	4.9		X Walk 2 X Slope (%)	3.4
N/A	Ramp inside XWalk1?	N/A	N/A	Ramp inside XWalk2?	N/A
	Road Slope (%)	4.6		Clear Space?	N/A
	Road X Slope (%)	0.3	N/A	Clear Space to XWalk (in)	N/A
			N/A	Any Obstruction?	N/A
				Obstruction Type	N/A
			N/A	Storm Grate/Utility Hazard?	N/A
				Storm Grate/Utility Type	N/A
Yes	Surface Condition? (G/P)	Good			
	Curb Slope (%)	17.0

**Remove & Replace Curb Ramp With Two New Directional Ramps or Equivalent.**

**\$ 3200.00**
