Access Compliance Report Public Rights-of-Way (Curb Ramps)

Intersection ID: 52112 Main Street: YOUNGBLOOD_ST Cross Street: POINDEXTER_DR Location: E

ADA ID: 288D97569F31 Ramp Type: Perp Initial Pass/Fail: Fail Overall Compliance: No Severity Score: 22.5

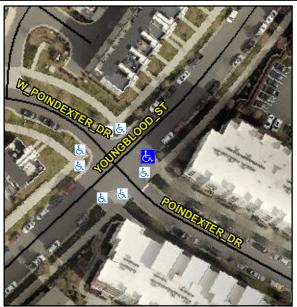
Field Measurements/Component Compliance						
Compliance Description		Data	Comp	liance Description	Data	
N/A	Ramp Length (in)	75.0	No	Ramp Slope (%)	9.1	
No	Ramp Width (in)	47.0	No	Ramp XSlope (%)	2.6	
N/A	Flare Type LT	N/A	N/A	Flare Type RT	N/A	
N/A	Flare Slope LT (%)	N/A	N/A	Flare Slope RT (%)	N/A	
N/A	Flare Traversable LT?	N/A	N/A	Flare Traversable RT?	N/A	
N/A	Landing Length (in)	N/A	N/A	DWS Provided?	N/A	
N/A	Landing Width (in)	N/A	N/A	DWS Contrast?	N/A	
N/A	Landing Slope (%)	N/A	N/A	DWS Length (in)	N/A	
N/A	Landing X Slope (%)	N/A	N/A	DWS Full Width?	N/A	
N/A	Landing Curb? (Y/N)	N/A	N/A	DWS Offset (in)	N/A	
N/A	Shared Landing?	N/A				
N/A	Gutter Ponding?	N/A	N/A	Gutter Slope (%)	N/A	
N/A	Gutter Lip Ht (in)	N/A	N/A	Gutter X Slope (%)	N/A	
N/A	Painted X Walk1?	No	N/A	Painted X Walk2?	N/A	
	X Walk 1 Direction	To NW		X Walk 2 Direction	N/A	
N/A	X Walk 1 Width (in)	N/A	N/A	X Walk 2 Width (in)	N/A	
	X Walk 1 Slope (%)	1.6		X Walk 2 Slope (%)	N/A

X Walk 1 X Slope (%)	1.3		X Walk 2 X Slope (%)	N/A	
N/A	Ramp inside XWalk1?	N/A	N/A	Ramp inside XWalk2?	N/A	
	Road Slope (%)	N/A	N/A	Clear Space?	N/A	
	Road X Slope (%)	N/A	N/A	Clear Space to XWalk (in)	N/A	
N/A	Any Obstructions?	N/A	N/A	Storm Grate/Utility Hazard?	N/A	
	Obstruction Type			Storm Grate/Utility Type		
		N/A			N/A	
			Yes	Surface Condition? (G/P)	Good

Fossible Solution						
Possible Solutions:						
Remove & Replace Entire Ramp.						
Surveyor Notes:						
N/A						
PROW/ADA:						
Not Found, R304.5.1, R304.2.2, R304.5.3						
1100-11010
