# Access Compliance Report

## Public Rights-of-Way

### (Curb Ramps)

Intersection ID: N/A	Main Street: COUNTRY_WALK_DR	Cross Street: FRESH_WIND_AV	Location: S
ADA ID: 289D6FEB7984	Ramp Type: PerpDiag	Initial Pass/Fail: Fail	Overall Compliance: No
		Severity Score: 8.75

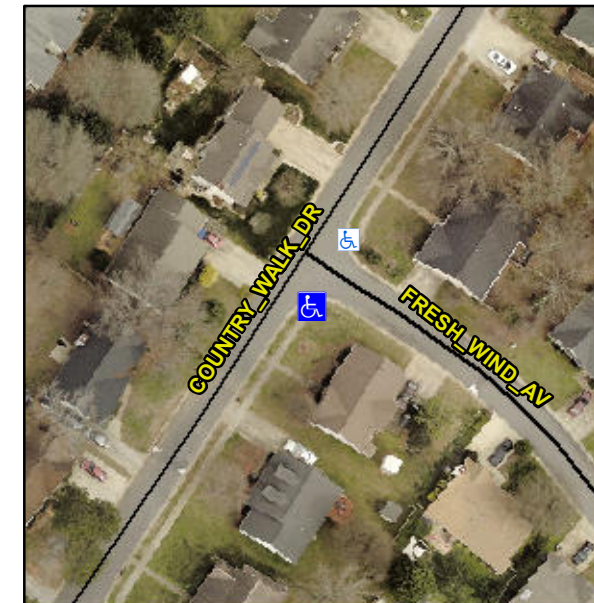
**Not Found, R304.5.1**

Compliance	Description	Data	Compliance	Description	Data
N/A	Ramp Length (in)	43.0	Yes	Ramp Slope (%)	5.8
No	Ramp Width (in)	44.0	Yes	Ramp XSlope (%)	1.2
N/A	Flare Type LT	N/A	N/A	Flare Type RT	N/A
N/A	Flare Slope LT (%)	N/A	N/A	Flare Slope RT (%)	N/A
N/A	Flare Traversable LT?	N/A	N/A	Flare Traversable RT?	N/A
N/A	Landing Length (in)	N/A	N/A	DWS Provided?	N/A
N/A	Landing Width (in)	N/A	N/A	DWS Contrast?	N/A
N/A	Landing Slope (%)	N/A	N/A	DWS Length (in)	N/A
N/A	Landing X Slope (%)	N/A	N/A	DWS Full Width?	N/A
N/A	Landing Curb? (Y/N)	N/A	N/A	DWS Offset (in)	N/A
N/A	Shared Landing?	N/A			
N/A	Gutter Ponding?	N/A	N/A	Gutter Slope (%)	N/A
N/A	Gutter Lip Ht (in)	N/A	N/A	Gutter X Slope (%)	N/A
N/A	Painted X Walk1?	No	N/A	Painted X Walk2?	No
	X Walk 1 Direction	To NE		X Walk 2 Direction	To NW
N/A	X Walk 1 Width (in)	N/A	N/A	X Walk 2 Width (in)	N/A
	X Walk 1 Slope (%)	1.0		X Walk 2 Slope (%)	5.4
	X Walk 1 X Slope (%)	3.4		X Walk 2 X Slope (%)	1.7

N/A	Ramp inside XWalk1?	N/A	N/A	Ramp inside XWalk2?	N/A
	Road Slope (%)	0.8	N/A	Clear Space?	N/A
	Road X Slope (%)	3.5	N/A	Clear Space to XWalk (in)	N/A
N/A	Any Obstructions?	N/A	N/A	Storm Grate/Utility Hazard?	N/A
	Obstruction Type			Storm Grate/Utility Type	
		N/A			N/A
			Yes	Surface Condition? (G/P)	Good

**Remove & Replace Curb Ramp With Two New Directional Ramps or Equivalent.**

Total Cost: \$ 3200.00
