Access Compliance Report

Public Rights-of-Way

(Curb Ramps)

Intersection ID: 23162	Main Street: SHARON_RD_WEST	Cross Street: SOUTH_BV	Location: NW
ADA ID: 28B631F8AFAC	Ramp Type: Perp	Initial Pass/Fail: Pass	Overall Compliance: No
		Severity Score: 0

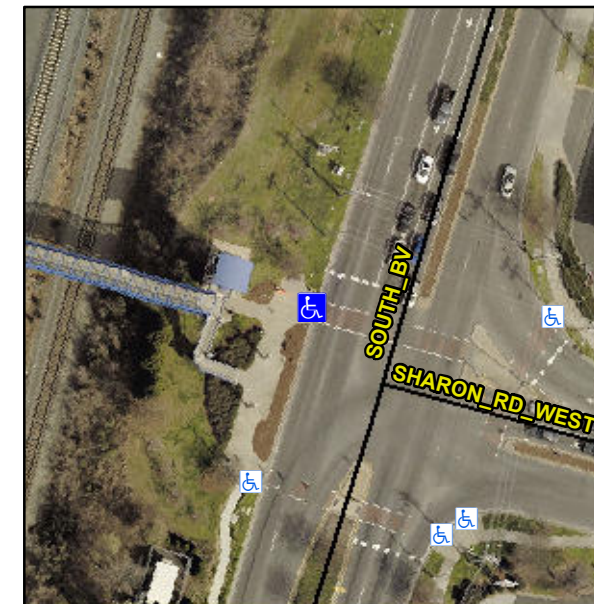
Compliance	Description	Data	Compliance	Description	Data
N/A	Ramp Length (in)	60.0	Yes	Ramp Slope (%)	5.8
Yes	Ramp Width (in)	48.0	Yes	Ramp XSlope (%)	1.0
N/A	Flare Type LT	Sloped	N/A	Flare Type RT	N/A
N/A	Flare Slope LT (%)	3.6	N/A	Flare Slope RT (%)	5.2
N/A	Flare Traversable LT?	No	N/A	Flare Traversable RT?	No
Yes	Landing Length (in)	48.0	Yes	DWS Provided?	Yes
Yes	Landing Width (in)	48.0	Yes	DWS Contrast?	Yes
No	Landing Slope (%)	3.6	Yes	DWS Length (in)	24.0
Yes	Landing X Slope (%)	0.4	Yes	DWS Full Width?	Yes
N/A	Landing Curb? (Y/N)	No	Yes	DWS Offset (in)	0.0
N/A	Shared Landing?	No			
Yes	Gutter Ponding?	No	Yes	Gutter Slope (%)	1.4
Yes	Gutter Lip Ht (in)	0.0	Yes	Gutter X Slope (%)	1.8
N/A	Painted X Walk1?	Yes	N/A	Painted X Walk2?	N/A
	X Walk 1 Direction	To SE		X Walk 2 Direction	N/A
N/A	X Walk 1 Width (in)	123.0	N/A	X Walk 2 Width (in)	N/A
	X Walk 1 Slope (%)	0.0		X Walk 2 Slope (%)	N/A
	X Walk 1 X Slope (%)	0.1		X Walk 2 X Slope (%)	N/A

Yes	Ramp inside XWalk1?	Yes	N/A	Ramp inside XWalk2?	N/A
	Road Slope (%)	N/A	N/A	Clear Space?	Yes
	Road X Slope (%)	N/A	N/A	Clear Space to XWalk (in)	N/A
Yes	Any Obstructions?	No	Yes	Storm Grate/Utility Hazard?	No
	Obstruction Type			Storm Grate/Utility Type	
		N/A			N/A
			Yes	Surface Condition? (G/P)	Good

Possible Solutions:

Remove & Replace Landing.

R304.2.2-Perp, R304.3.2-Para

\$ 500.00
