Access Compliance Report

Public Rights-of-Way

(Curb Ramps)

Intersection ID: 8228	Main Street: CROSSRIDGE_RD	Cross Street: SULLINS_RD	Location:	N
ADA ID: 28B7CA15FC77	Ramp Type: Perp	Initial Pass/Fail: Fail	Overall Compliance: No	Severity Score: 10
Codes/Mitigation Info/Possible Solution		Field Measurements/Component Compliance

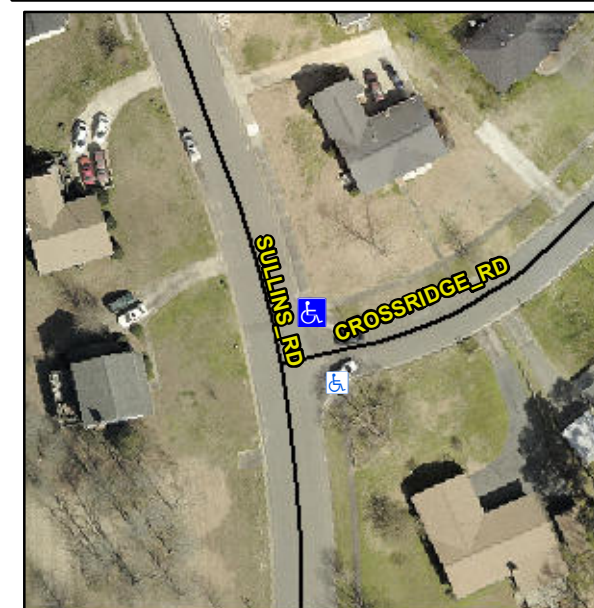
Not Found, R304.5.1, R304.5.3

Compliance	Description	Data	Compliance	Description	Data
N/A	Ramp Length (in)	72.0	Yes	Ramp Slope (%)	5.0
No	Ramp Width (in)	47.5	No	Ramp XSlope (%)	3.2
N/A	Flare Type LT	N/A	N/A	Flare Type RT	N/A
N/A	Flare Slope LT (%)	N/A	N/A	Flare Slope RT (%)	N/A
N/A	Flare Traversable LT?	N/A	N/A	Flare Traversable RT?	N/A
N/A	Landing Length (in)	N/A	N/A	DWS Provided?	N/A
N/A	Landing Width (in)	N/A	N/A	DWS Contrast?	N/A
N/A	Landing Slope (%)	N/A	N/A	DWS Length (in)	N/A
N/A	Landing X Slope (%)	N/A	N/A	DWS Full Width?	N/A
N/A	Landing Curb? (Y/N)	N/A	N/A	DWS Offset (in)	N/A
N/A	Shared Landing?	N/A			
N/A	Gutter Ponding?	N/A	N/A	Gutter Slope (%)	N/A
N/A	Gutter Lip Ht (in)	0.5	N/A	Gutter X Slope (%)	N/A
N/A	Painted X Walk1?	No	N/A	Painted X Walk2?	N/A
	X Walk 1 Direction	To S		X Walk 2 Direction	N/A
N/A	X Walk 1 Width (in)	N/A	N/A	X Walk 2 Width (in)	N/A
	X Walk 1 Slope (%)	0.3		X Walk 2 Slope (%)	N/A
	X Walk 1 X Slope (%)	5.6		X Walk 2 X Slope (%)	N/A

N/A	Ramp inside XWalk1?	N/A	N/A	Ramp inside XWalk2?	N/A
	Road Slope (%)	N/A	N/A	Clear Space?	N/A
	Road X Slope (%)	N/A	N/A	Clear Space to XWalk (in)	N/A
N/A	Any Obstructions?	N/A	N/A	Storm Grate/Utility Hazard?	N/A
	Obstruction Type			Storm Grate/Utility Type	
		N/A			N/A
			Yes	Surface Condition? (G/P)	Good

Possible Solutions:

Remove & Replace Entire Ramp.

Total Cost: \$ 1850.00
