Access Compliance Report

Public Rights-of-Way

(Curb Ramps)

Intersection ID: 4649	Main Street: BLUE_ASTER_LN	Cross Street: CHASEWIND_DR	Location:	N
ADA ID: 28B93D9B2B46	Ramp Type: Perp	Initial Pass/Fail: Fail	Overall Compliance: No	Severity Score: 13.75
Codes/Mitigation Info/Possible Solution		Field Measurements/Component Compliance

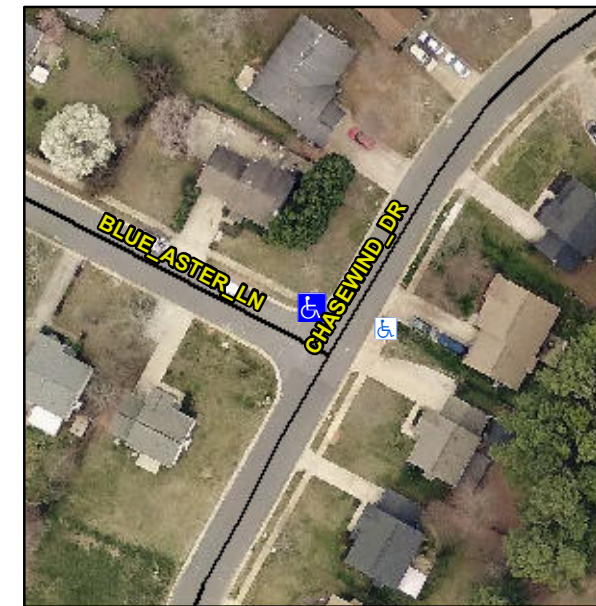
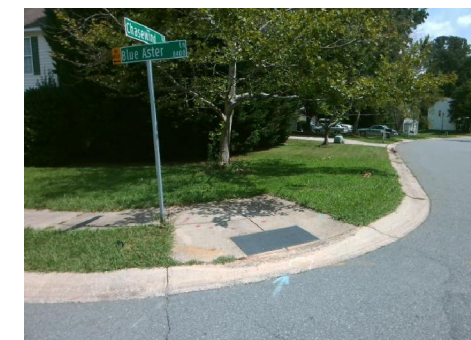
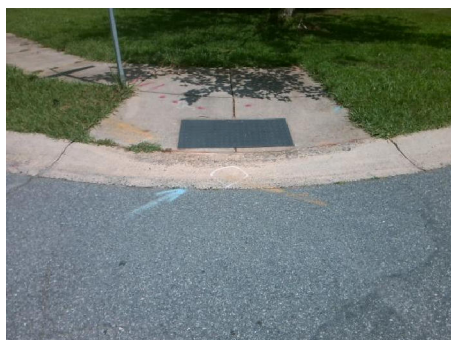
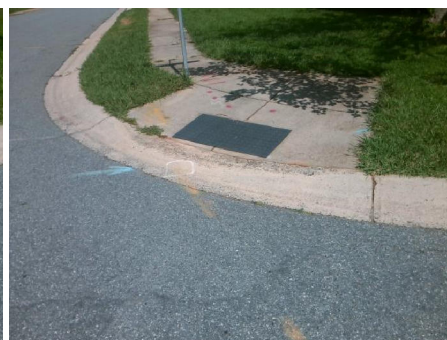
Not Found, R304.2.2, R304.5.3

Compliance	Description	Data	Compliance	Description	Data
N/A	Ramp Length (in)	51.0	No	Ramp Slope (%)	8.8
Yes	Ramp Width (in)	48.0	No	Ramp XSlope (%)	2.2
N/A	Flare Type LT	N/A	N/A	Flare Type RT	N/A
N/A	Flare Slope LT (%)	N/A	N/A	Flare Slope RT (%)	N/A
N/A	Flare Traversable LT?	N/A	N/A	Flare Traversable RT?	N/A
N/A	Landing Length (in)	N/A	N/A	DWS Provided?	N/A
N/A	Landing Width (in)	N/A	N/A	DWS Contrast?	N/A
N/A	Landing Slope (%)	N/A	N/A	DWS Length (in)	N/A
N/A	Landing X Slope (%)	N/A	N/A	DWS Full Width?	N/A
N/A	Landing Curb? (Y/N)	N/A	N/A	DWS Offset (in)	N/A
N/A	Shared Landing?	N/A			
N/A	Gutter Ponding?	N/A	N/A	Gutter Slope (%)	N/A
N/A	Gutter Lip Ht (in)	N/A	N/A	Gutter X Slope (%)	N/A
N/A	Painted X Walk1?	No	N/A	Painted X Walk2?	N/A
	X Walk 1 Direction	To SE		X Walk 2 Direction	N/A
N/A	X Walk 1 Width (in)	N/A	N/A	X Walk 2 Width (in)	N/A
	X Walk 1 Slope (%)	7.0		X Walk 2 Slope (%)	N/A
	X Walk 1 X Slope (%)	0.8		X Walk 2 X Slope (%)	N/A

N/A	Ramp inside XWalk1?	N/A	N/A	Ramp inside XWalk2?	N/A
	Road Slope (%)	N/A	N/A	Clear Space?	N/A
	Road X Slope (%)	N/A	N/A	Clear Space to XWalk (in)	N/A
N/A	Any Obstructions?	N/A	N/A	Storm Grate/Utility Hazard?	N/A
	Obstruction Type			Storm Grate/Utility Type	
		N/A			N/A
			Yes	Surface Condition? (G/P)	Good

Possible Solutions:

Remove & Replace Entire Ramp.

Total Cost: \$ 1850.00
