# Access Compliance Report

## Public Rights-of-Way

### (Curb Ramps)

Intersection ID: 10021826	Main Street: BRISTLE_TOE_LN	Cross Street: N/A	Location: SW
ADA ID: 28BB0223C46F	Ramp Type: PerpDiag	Initial Pass/Fail: Fail	Overall Compliance: No
		Severity Score: 12.5

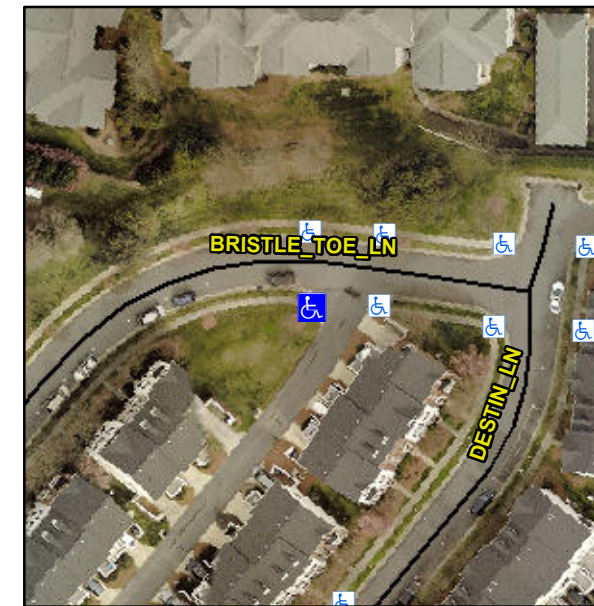
**Not Found, R304.5.3**

Compliance	Description	Data	Compliance	Description	Data
N/A	Ramp Length (in)	50.0	Yes	Ramp Slope (%)	6.4
Yes	Ramp Width (in)	48.0	No	Ramp XSlope (%)	5.2
N/A	Flare Type LT	N/A	N/A	Flare Type RT	N/A
N/A	Flare Slope LT (%)	N/A	N/A	Flare Slope RT (%)	N/A
N/A	Flare Traversable LT?	N/A	N/A	Flare Traversable RT?	N/A
N/A	Landing Length (in)	N/A	N/A	DWS Provided?	N/A
N/A	Landing Width (in)	N/A	N/A	DWS Contrast?	N/A
N/A	Landing Slope (%)	N/A	N/A	DWS Length (in)	N/A
N/A	Landing X Slope (%)	N/A	N/A	DWS Full Width?	N/A
N/A	Landing Curb? (Y/N)	N/A	N/A	DWS Offset (in)	N/A
N/A	Shared Landing?	N/A			
N/A	Gutter Ponding?	N/A	N/A	Gutter Slope (%)	N/A
N/A	Gutter Lip Ht (in)	N/A	N/A	Gutter X Slope (%)	N/A
N/A	Painted X Walk1?	No	N/A	Painted X Walk2?	No
	X Walk 1 Direction	To E		X Walk 2 Direction	To N
N/A	X Walk 1 Width (in)	N/A	N/A	X Walk 2 Width (in)	N/A
	X Walk 1 Slope (%)	1.7		X Walk 2 Slope (%)	1.1
	X Walk 1 X Slope (%)	4.5		X Walk 2 X Slope (%)	0.3

N/A	Ramp inside XWalk1?	N/A	N/A	Ramp inside XWalk2?	N/A
	Road Slope (%)	4.9	N/A	Clear Space?	N/A
	Road X Slope (%)	3.3	N/A	Clear Space to XWalk (in)	N/A
N/A	Any Obstructions?	N/A	N/A	Storm Grate/Utility Hazard?	N/A
	Obstruction Type			Storm Grate/Utility Type	
		N/A			N/A
		Yes		Surface Condition? (G/P)	Good

**Remove & Replace Curb Ramp With Two New Directional Ramps or Equivalent.**
