Access Compliance Report

Public Rights-of-Way

(Curb Ramps)

Intersection ID: N/A	Main Street: PARK_SOUTH_DR	Cross Street: ARCHDALE_DR	Location: NW
ADA ID: 28C0A8914073	Ramp Type: PerpDiag	Initial Pass/Fail: Fail	Overall Compliance: No
		Severity Score: 12.5

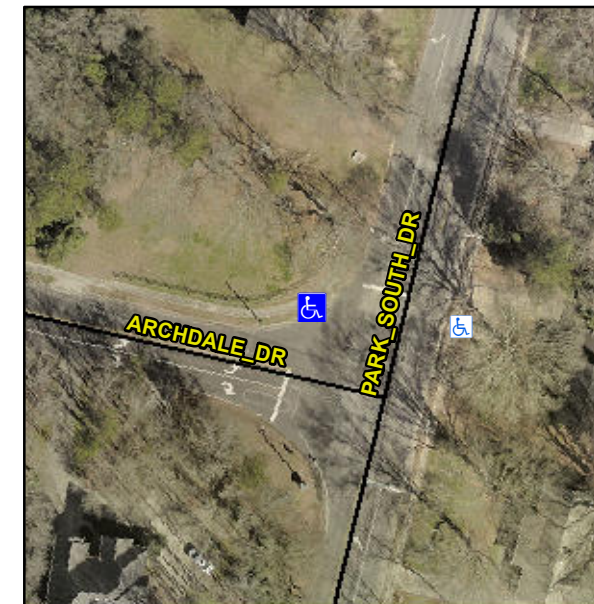
Not Found, R304.2.2

Compliance	Description	Data	Compliance	Description	Data
N/A	Ramp Length (in)	53.0	No	Ramp Slope (%)	9.4
Yes	Ramp Width (in)	55.0	Yes	Ramp XSlope (%)	0.9
N/A	Flare Type LT	N/A	N/A	Flare Type RT	N/A
N/A	Flare Slope LT (%)	N/A	N/A	Flare Slope RT (%)	N/A
N/A	Flare Traversable LT?	N/A	N/A	Flare Traversable RT?	N/A
N/A	Landing Length (in)	N/A	N/A	DWS Provided?	N/A
N/A	Landing Width (in)	N/A	N/A	DWS Contrast?	N/A
N/A	Landing Slope (%)	N/A	N/A	DWS Length (in)	N/A
N/A	Landing X Slope (%)	N/A	N/A	DWS Full Width?	N/A
N/A	Landing Curb? (Y/N)	N/A	N/A	DWS Offset (in)	N/A
N/A	Shared Landing?	N/A			
N/A	Gutter Ponding?	N/A	N/A	Gutter Slope (%)	N/A
N/A	Gutter Lip Ht (in)	N/A	N/A	Gutter X Slope (%)	N/A
N/A	Painted X Walk1?	No	N/A	Painted X Walk2?	No
	X Walk 1 Direction	To SW		X Walk 2 Direction	To SE
N/A	X Walk 1 Width (in)	N/A	N/A	X Walk 2 Width (in)	N/A
	X Walk 1 Slope (%)	2.6		X Walk 2 Slope (%)	2.1
	X Walk 1 X Slope (%)	2.1		X Walk 2 X Slope (%)	4.8

N/A	Ramp inside XWalk1?	N/A	N/A	Ramp inside XWalk2?	N/A
	Road Slope (%)	1.5	N/A	Clear Space?	N/A
	Road X Slope (%)	5.3	N/A	Clear Space to XWalk (in)	N/A
N/A	Any Obstructions?	N/A	N/A	Storm Grate/Utility Hazard?	N/A
	Obstruction Type			Storm Grate/Utility Type	
		N/A			N/A
			Yes	Surface Condition? (G/P)	Good

Remove & Replace Curb Ramp With Two New Directional Ramps or Equivalent.
