Access Compliance Report

Public Rights-of-Way

(Curb Ramps)

Intersection ID: 10018398	Main Street: CRANBOURN_CT	Cross Street: N/A	Location:	N
ADA ID: 28C2816FD9B5	Ramp Type: Perp	Initial Pass/Fail: Pass	Overall Compliance: No	Severity Score: 5

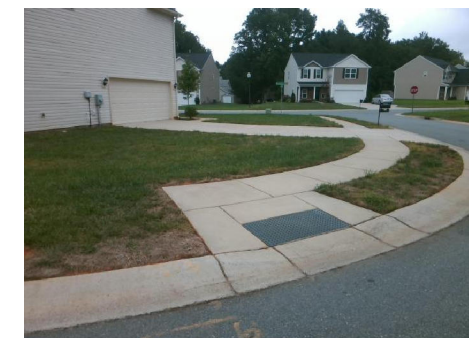
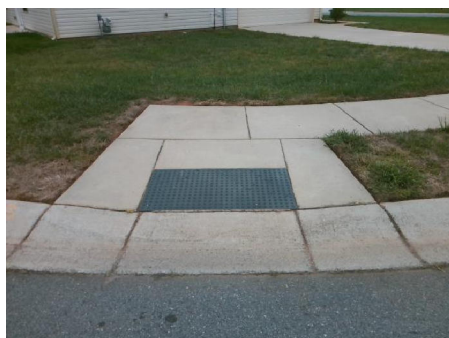
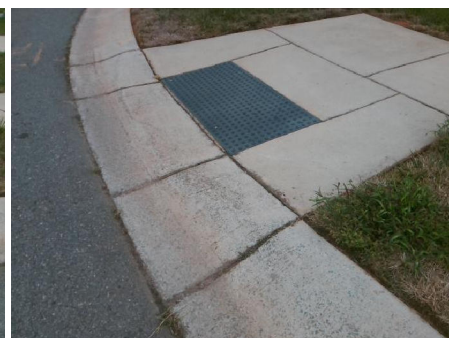
Compliance	Description	Data	Compliance	Description	Data
N/A	Ramp Length (in)	48.5	Yes	Ramp Slope (%)	7.1
Yes	Ramp Width (in)	48.0	Yes	Ramp XSlope (%)	0.2
N/A	Flare Type LT	Sloped	N/A	Flare Type RT	N/A
N/A	Flare Slope LT (%)	8.5	N/A	Flare Slope RT (%)	6.2
N/A	Flare Traversable LT?	No	N/A	Flare Traversable RT?	No
No	Landing Length (in)	46.5	Yes	DWS Provided?	Yes
Yes	Landing Width (in)	48.0	Yes	DWS Contrast?	Yes
Yes	Landing Slope (%)	1.7	Yes	DWS Length (in)	24.5
Yes	Landing X Slope (%)	0.9	Yes	DWS Full Width?	Yes
N/A	Landing Curb? (Y/N)	No	Yes	DWS Offset (in)	0.8
N/A	Shared Landing?	No			
No	Gutter Ponding?	Yes	No	Gutter Slope (%)	6.6
Yes	Gutter Lip Ht (in)	0.0	Yes	Gutter X Slope (%)	0.2
N/A	Painted X Walk1?	No	N/A	Painted X Walk2?	N/A
	X Walk 1 Direction	To S		X Walk 2 Direction	N/A
N/A	X Walk 1 Width (in)	N/A	N/A	X Walk 2 Width (in)	N/A
	X Walk 1 Slope (%)	4.9		X Walk 2 Slope (%)	N/A
	X Walk 1 X Slope (%)	0.6		X Walk 2 X Slope (%)	N/A

N/A	Ramp inside XWalk1?	N/A	N/A	Ramp inside XWalk2?	N/A
	Road Slope (%)	N/A	N/A	Clear Space?	Yes
	Road X Slope (%)	N/A	N/A	Clear Space to XWalk (in)	N/A
Yes	Any Obstructions?	No	Yes	Storm Grate/Utility Hazard?	No
	Obstruction Type			Storm Grate/Utility Type	
			N/A		N/A
			Yes	Surface Condition? (G/P)	Good

Possible Solutions:

**Remove & Replace Entire Ramp.
Remove & Replace Gutter.**
