Access Compliance Report

Public Rights-of-Way

(Curb Ramps)

Intersection ID: 13763	Main Street: CENTRAL_AV	Cross Street: EASTWAY_DR	Location: SW
ADA ID: 28CB189DD93A	Ramp Type: Perp	Initial Pass/Fail: Fail	Overall Compliance: No
Severity Score: 8.75			
Codes/Mitigation Info/Possible Solution		Field Measurements/Component Compliance

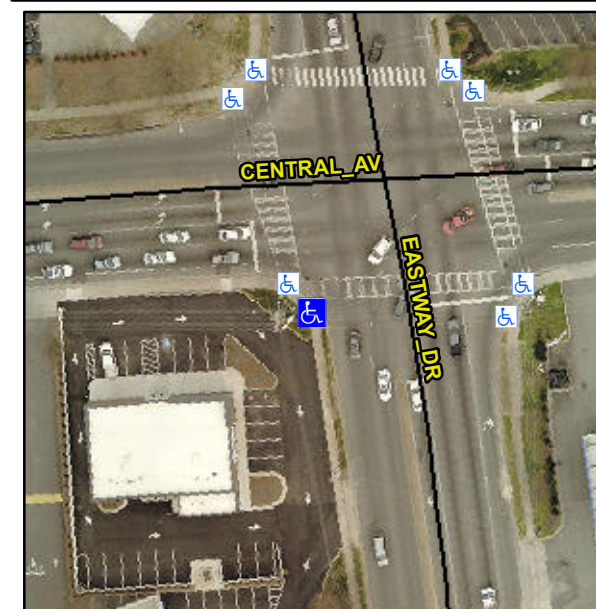
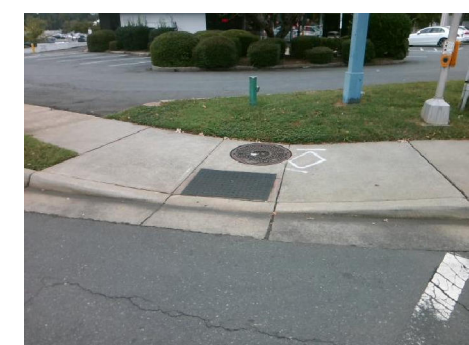
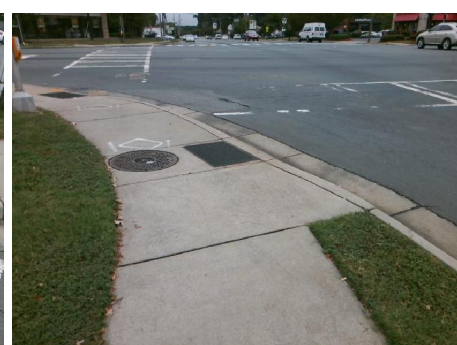
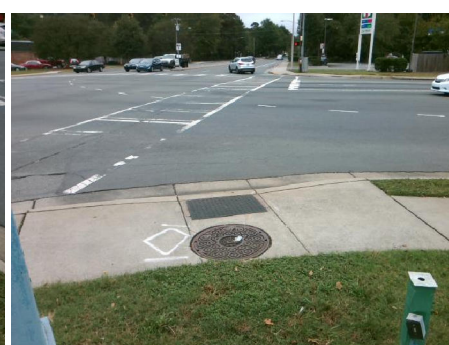
Not Found, R304.5.1

Compliance	Description	Data	Compliance	Description	Data
N/A	Ramp Length (in)	80.0	Yes	Ramp Slope (%)	5.9
No	Ramp Width (in)	45.0	Yes	Ramp XSlope (%)	1.6
N/A	Flare Type LT	N/A	N/A	Flare Type RT	N/A
N/A	Flare Slope LT (%)	N/A	N/A	Flare Slope RT (%)	N/A
N/A	Flare Traversable LT?	N/A	N/A	Flare Traversable RT?	N/A
N/A	Landing Length (in)	N/A	N/A	DWS Provided?	N/A
N/A	Landing Width (in)	N/A	N/A	DWS Contrast?	N/A
N/A	Landing Slope (%)	N/A	N/A	DWS Length (in)	N/A
N/A	Landing X Slope (%)	N/A	N/A	DWS Full Width?	N/A
N/A	Landing Curb? (Y/N)	N/A	N/A	DWS Offset (in)	N/A
N/A	Shared Landing?	N/A			
N/A	Gutter Ponding?	N/A	N/A	Gutter Slope (%)	N/A
N/A	Gutter Lip Ht (in)	N/A	N/A	Gutter X Slope (%)	N/A
N/A	Painted X Walk1?	No	N/A	Painted X Walk2?	N/A
	X Walk 1 Direction	To E		X Walk 2 Direction	N/A
N/A	X Walk 1 Width (in)	N/A	N/A	X Walk 2 Width (in)	N/A
	X Walk 1 Slope (%)	4.0		X Walk 2 Slope (%)	N/A
	X Walk 1 X Slope (%)	3.0		X Walk 2 X Slope (%)	N/A

N/A	Ramp inside XWalk1?	N/A	N/A	Ramp inside XWalk2?	N/A
	Road Slope (%)	N/A	N/A	Clear Space?	N/A
	Road X Slope (%)	N/A	N/A	Clear Space to XWalk (in)	N/A
N/A	Any Obstructions?	N/A	N/A	Storm Grate/Utility Hazard?	N/A
	Obstruction Type			Storm Grate/Utility Type	
		N/A			N/A
			Yes	Surface Condition? (G/P)	Good

Remove & Replace Entire Ramp.
