Access Compliance Report

Public Rights-of-Way

(Curb Ramps)

Intersection ID: 16090	Main Street: SARAH_DR	Cross Street: STEGALL_ST	Location: W
ADA ID: 28EBF6954351	Ramp Type: PerpDiag	Initial Pass/Fail: Fail	Overall Compliance: No
Codes/Mitigation Info/Possible Solution		Field Measurements/Component Compliance

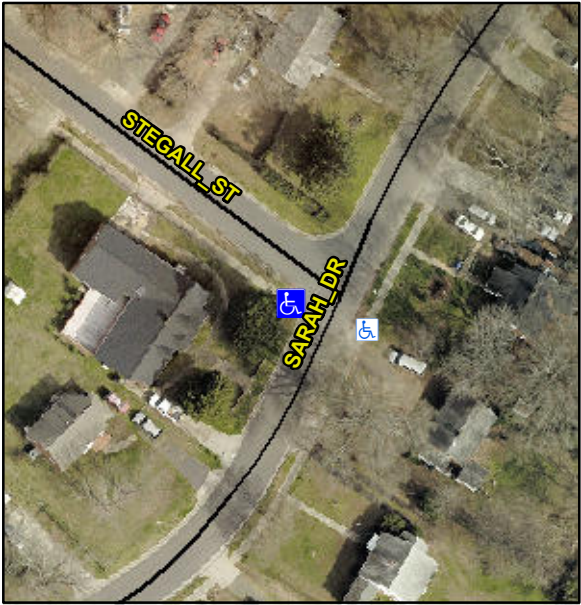
N/A	Ramp inside XWalk1?	N/A
			Road Slope (%)	5.1
			Road X Slope (%)	4.7
		N/A	Any Obstructions?	N/A
			Obstruction Type	
		N/A		N/A
		Yes	Surface Condition? (G/P)	Good

Possible Solutions:			
	Remove & Replace Curb Ramp With Two New Directional Ramps or Equivalent.			
<p>Surveyor Notes:</p> <p>N/A</p>	<p>PROW/ADA:</p> <p>Not Found, R304.5.1, R304.2.2</p>	Compliance	Description	Data
		N/A	Ramp Length (in)	47.0
<p>Street 1 Name</p> <p>SARAH DR</p>	<p>Stop Condition-Street 2</p> <p>None</p>	No	Ramp Width (in)	47.0
		N/A	Flare Type LT	N/A
<p>Street 2 Name</p> <p>STEGALL ST</p>	<p>Stop Condition-Street 1</p> <p>StopSign</p>	N/A	Flare Slope LT (%)	N/A
		N/A	Flare Traversable LT?	N/A
<p>Total Cost:</p> <p>\$ 3200.00</p>		N/A	Landing Length (in)	N/A
		N/A	Landing Width (in)	N/A
		N/A	Landing Slope (%)	N/A
		N/A	Landing X Slope (%)	N/A
		N/A	Landing Curb? (Y/N)	N/A
		N/A	Shared Landing?	N/A
		N/A	Gutter Ponding?	N/A
		N/A	Gutter Lip Ht (in)	N/A
		N/A	Painted X Walk1?	No
			X Walk 1 Direction	To SE
		N/A	X Walk 1 Width (in)	N/A
			X Walk 1 Slope (%)	6.1
			X Walk 1 X Slope (%)	2.0
