# Access Compliance Report

## Public Rights-of-Way

### (Curb Ramps)

| Intersection ID: 30272 | Main Street: CHALLENGER_DR | Cross Street: OLD_IRONSIDE_DR | Location: E |

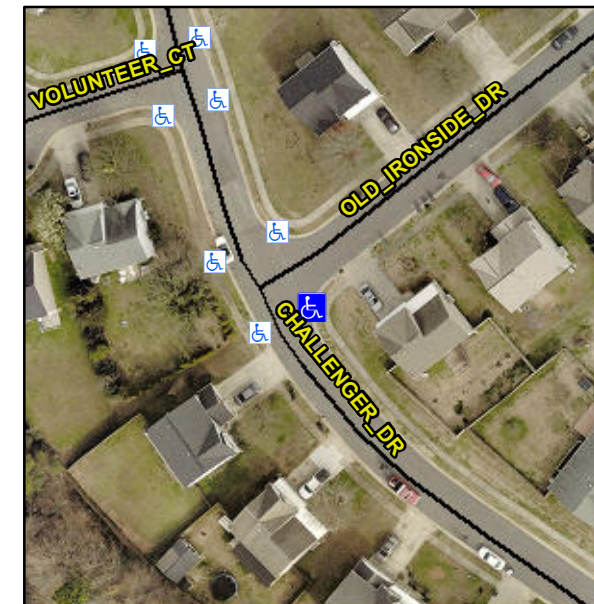
**Not Found, R304.5.3, R304.2.1, R305.2**

| Compliance | Description | Data | Compliance | Description | Data |
|---|---|---|---|---|---|
| Yes | Ramp Width (in) | 48.0 | No | BlendTrans XSlope (%) | 2.2 |
| No | Landing Length (in) | 46.0 | Yes | DWS Provided? | Yes |
| No | Landing X Slope (%) | 2.8 | Yes | DWS Full Width? | Yes |
| N/A | Landing Curb? (Y/N) | No | No | DWS Offset (in) | 5.5 |

**Remove & Replace Curb Ramp With Two New Directional Ramps or Equivalent.**
