# Access Compliance Report

## Public Rights-of-Way

### (Curb Ramps)

| Intersection ID: 47035 | Main Street: W_ARROWOOD_RD | Cross Street: STONEGROVE_LN | Location: SW |

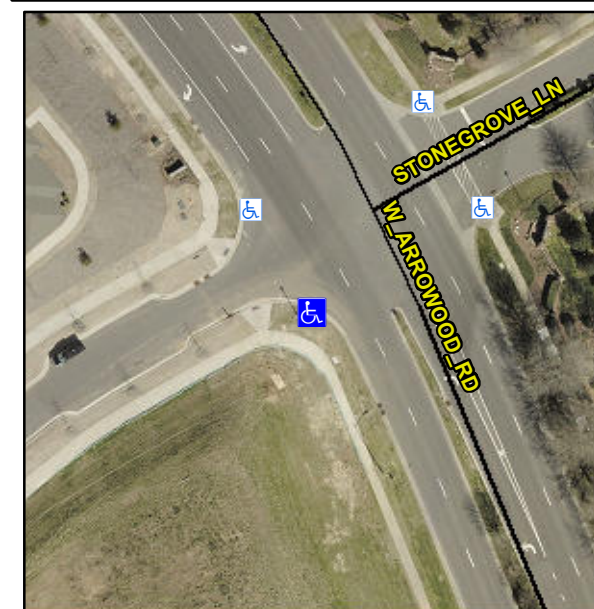
**Not Found, R304.2.2-Perp, R304.3.2-Para, R305.1.4, R305.2, R304.5.3**

| Compliance | Description | Data | Compliance | Description | Data |
|---|---|---|---|---|---|
| No | Landing Slope (%) | 2.1 | Yes | DWS Length (in) | 24.0 |
| Yes | Landing X Slope (%) | 0.1 | No | DWS Full Width? | No |
| N/A | Landing Curb? (Y/N) | No | No | DWS Offset (in) | 5.0 |
| Yes | Gutter Lip Ht (in) | 0.0 | No | Gutter X Slope (%) | 2.1 |

**Remove & Replace Curb Ramp With Two New Directional Ramps or Equivalent. Remove & Replace Gutter.**

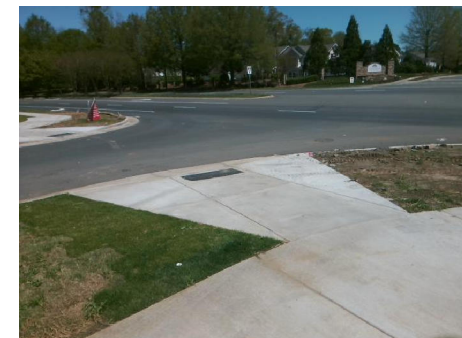
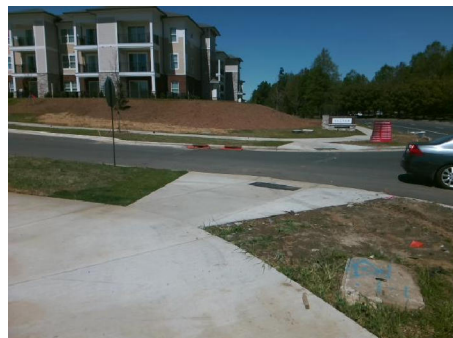
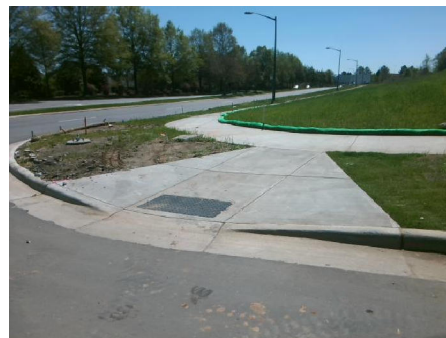
| Compliance | Description | Data | Compliance | Description | Data |
|---|---|---|---|---|---|
| | | | No | Curb Slope (%) | 10.0 |
