# Access Compliance Report

## Public Rights-of-Way

| Intersection ID: 17610 | Main Street: EMORY_LN | Cross Street: N_SHARON_AMITY_RD | Location: NE |
| ADA ID: 28FB7503700F | Ramp Type: Directional1 | Initial Pass/Fail: Fail | Overall Compliance: No |

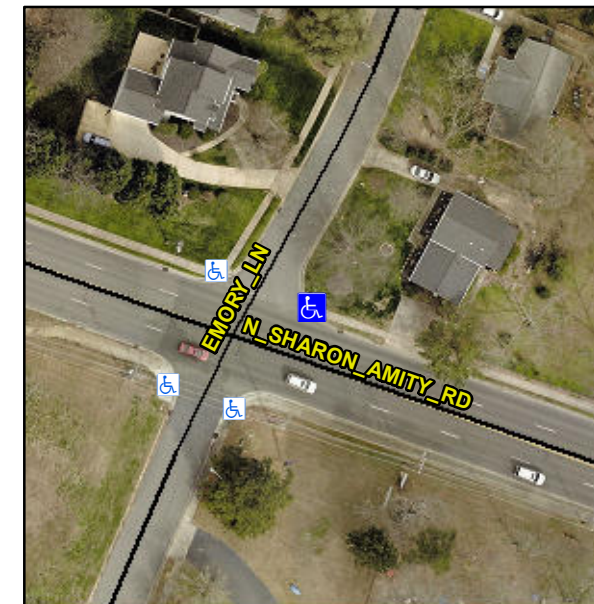
| | | Severity Score: 25 | |

**R304.5.3**

| Compliance | Description | Data | Compliance | Description | Data |
|---|---|---|---|---|---|
| No | Ramp XSlope (%) | 8.7 | | | |

**Remove & Replace Entire Ramp.**

\$ 1600.00
