Access Compliance Report

Public Rights-of-Way

(Curb Ramps)

Intersection ID: 50584	Main Street: GREAT_LAUREL_RD	Cross Street: GRAND_FIR_RD	Location: SW
ADA ID: 29085EBA380E	Ramp Type: Perp	Initial Pass/Fail: Fail	Overall Compliance: No
Severity Score: 10			
Codes/Mitigation Info/Possible Solution		Field Measurements/Component Compliance

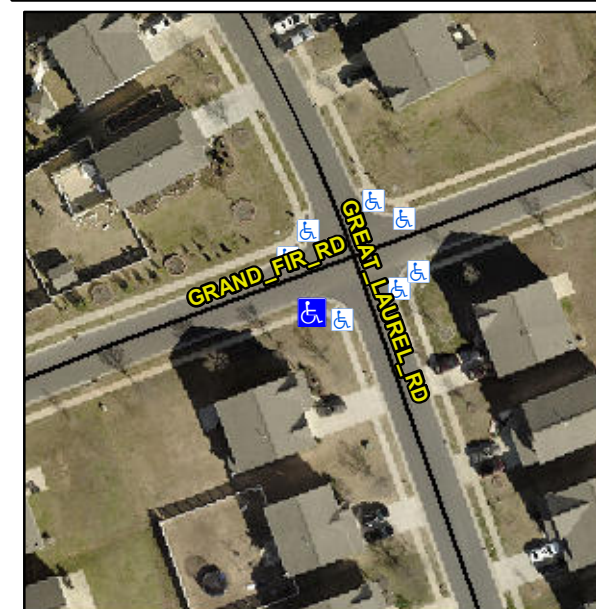
Not Found, R304.5.1

Compliance	Description	Data	Compliance	Description	Data
N/A	Ramp Length (in)	48.0	Yes	Ramp Slope (%)	5.6
No	Ramp Width (in)	46.0	Yes	Ramp XSlope (%)	2.1
N/A	Flare Type LT	N/A	N/A	Flare Type RT	N/A
N/A	Flare Slope LT (%)	N/A	N/A	Flare Slope RT (%)	N/A
N/A	Flare Traversable LT?	N/A	N/A	Flare Traversable RT?	N/A
N/A	Landing Length (in)	N/A	N/A	DWS Provided?	N/A
N/A	Landing Width (in)	N/A	N/A	DWS Contrast?	N/A
N/A	Landing Slope (%)	N/A	N/A	DWS Length (in)	N/A
N/A	Landing X Slope (%)	N/A	N/A	DWS Full Width?	N/A
N/A	Landing Curb? (Y/N)	N/A	N/A	DWS Offset (in)	N/A
N/A	Shared Landing?	N/A			
N/A	Gutter Ponding?	N/A	N/A	Gutter Slope (%)	N/A
N/A	Gutter Lip Ht (in)	N/A	N/A	Gutter X Slope (%)	N/A
N/A	Painted X Walk1?	No	N/A	Painted X Walk2?	N/A
	X Walk 1 Direction	To N		X Walk 2 Direction	N/A
N/A	X Walk 1 Width (in)	N/A	N/A	X Walk 2 Width (in)	N/A
	X Walk 1 Slope (%)	1.5		X Walk 2 Slope (%)	N/A
	X Walk 1 X Slope (%)	2.1		X Walk 2 X Slope (%)	N/A

Possible Solutions:

Remove & Replace Entire Ramp.

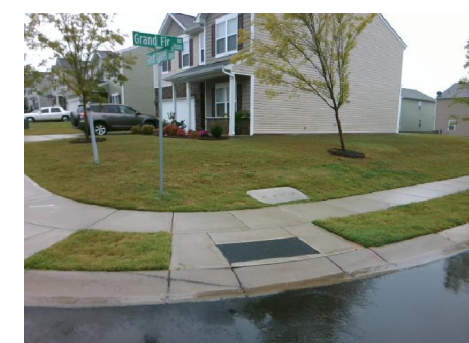
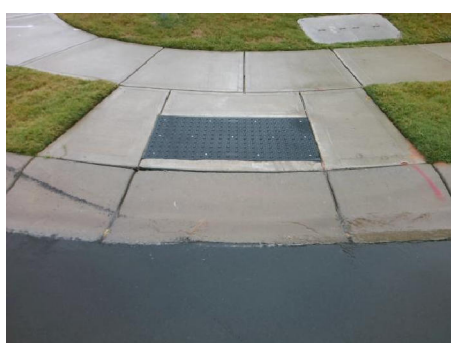
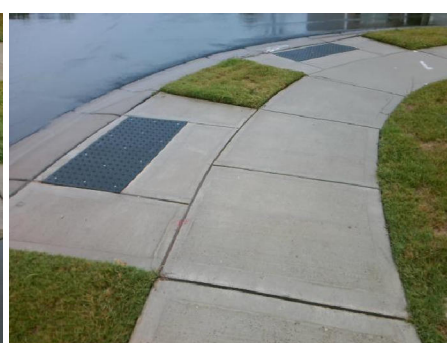
N/A	Ramp inside XWalk1?	N/A	N/A	Ramp inside XWalk2?	N/A
	Road Slope (%)	N/A	N/A	Clear Space?	N/A
	Road X Slope (%)	N/A	N/A	Clear Space to XWalk (in)	N/A
N/A	Any Obstructions?	N/A	N/A	Storm Grate/Utility Hazard?	N/A
	Obstruction Type			Storm Grate/Utility Type	
		N/A			N/A
		Yes		Surface Condition? (G/P)	Good
