Access Compliance Report

Public Rights-of-Way

(Curb Ramps)

Intersection ID: 42369	Main Street: BENTGRASS_RUN_DR	Cross Street: LYLETON_LN	Location: W
ADA ID: 291C8E8FB7AB	Ramp Type: PerpDiag	Initial Pass/Fail: Fail	Overall Compliance: No
Severity Score: 21.25			
Codes/Mitigation Info/Possible Solution		Field Measurements/Component Compliance

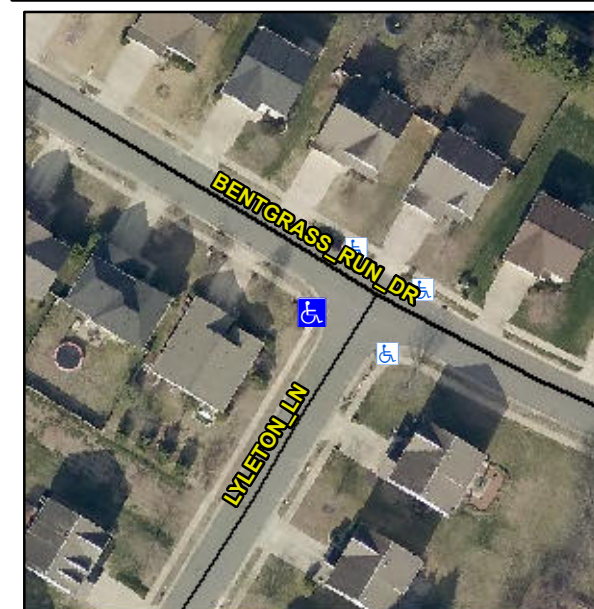
Compliance	Description	Data	Compliance	Description	Data
N/A	Ramp Length (in)	43.0	No	Ramp Slope (%)	11.5
No	Ramp Width (in)	46.5	Yes	Ramp XSlope (%)	1.3
N/A	Flare Type LT	N/A	N/A	Flare Type RT	N/A
N/A	Flare Slope LT (%)	N/A	N/A	Flare Slope RT (%)	N/A
N/A	Flare Traversable LT?	N/A	N/A	Flare Traversable RT?	N/A
N/A	Landing Length (in)	N/A	N/A	DWS Provided?	N/A
N/A	Landing Width (in)	N/A	N/A	DWS Contrast?	N/A
N/A	Landing Slope (%)	N/A	N/A	DWS Length (in)	N/A
N/A	Landing X Slope (%)	N/A	N/A	DWS Full Width?	N/A
N/A	Landing Curb? (Y/N)	N/A	N/A	DWS Offset (in)	N/A
N/A	Shared Landing?	N/A			
N/A	Gutter Ponding?	N/A	N/A	Gutter Slope (%)	N/A
N/A	Gutter Lip Ht (in)	N/A	N/A	Gutter X Slope (%)	N/A
N/A	Painted X Walk1?	No	N/A	Painted X Walk2?	No
	X Walk 1 Direction	To SE		X Walk 2 Direction	To NE
N/A	X Walk 1 Width (in)	N/A	N/A	X Walk 2 Width (in)	N/A
	X Walk 1 Slope (%)	0.7		X Walk 2 Slope (%)	1.4
	X Walk 1 X Slope (%)	0.9		X Walk 2 X Slope (%)	2.2

N/A	Ramp inside XWalk1?	N/A	N/A	Ramp inside XWalk2?	N/A
	Road Slope (%)	2.6	N/A	Clear Space?	N/A
	Road X Slope (%)	0.3	N/A	Clear Space to XWalk (in)	N/A
N/A	Any Obstructions?	N/A	N/A	Storm Grate/Utility Hazard?	N/A
	Obstruction Type			Storm Grate/Utility Type	
		N/A			N/A
			Yes	Surface Condition? (G/P)	Good

Possible Solutions:

Remove & Replace Curb Ramp With Two New Directional Ramps or Equivalent.

R304.5.1, R304.2.2
