Access Compliance Report

Public Rights-of-Way

(Curb Ramps)

Intersection ID: 10719	Main Street: CEMETARY_ST	Cross Street: N_SUMMIT_AV	Location: E
ADA ID: 291EDE3601F7	Ramp Type: PerpDiag	Initial Pass/Fail: Fail	Overall Compliance: No
			Severity Score: 33.75

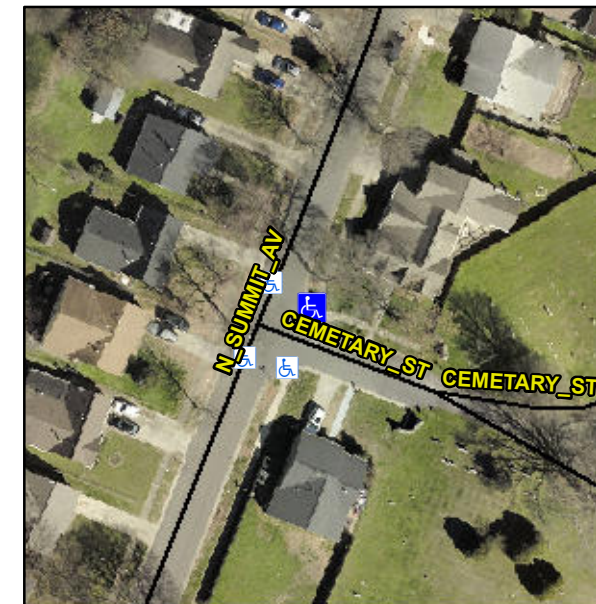
Not Found, R304.5.1, R304.5.3

Compliance	Description	Data	Compliance	Description	Data
N/A	Ramp Length (in)	37.0	Yes	Ramp Slope (%)	6.7
No	Ramp Width (in)	47.5	No	Ramp XSlope (%)	7.5
N/A	Flare Type LT	N/A	N/A	Flare Type RT	N/A
N/A	Flare Slope LT (%)	N/A	N/A	Flare Slope RT (%)	N/A
N/A	Flare Traversable LT?	N/A	N/A	Flare Traversable RT?	N/A
N/A	Landing Length (in)	N/A	N/A	DWS Provided?	N/A
N/A	Landing Width (in)	N/A	N/A	DWS Contrast?	N/A
N/A	Landing Slope (%)	N/A	N/A	DWS Length (in)	N/A
N/A	Landing X Slope (%)	N/A	N/A	DWS Full Width?	N/A
N/A	Landing Curb? (Y/N)	N/A	N/A	DWS Offset (in)	N/A
N/A	Shared Landing?	N/A			
N/A	Gutter Ponding?	N/A	N/A	Gutter Slope (%)	N/A
N/A	Gutter Lip Ht (in)	0.5	N/A	Gutter X Slope (%)	N/A
N/A	Painted X Walk1?	No	N/A	Painted X Walk2?	No
	X Walk 1 Direction	To NW		X Walk 2 Direction	To SW
N/A	X Walk 1 Width (in)	N/A	N/A	X Walk 2 Width (in)	N/A
	X Walk 1 Slope (%)	5.5		X Walk 2 Slope (%)	3.0
	X Walk 1 X Slope (%)	2.8		X Walk 2 X Slope (%)	6.6

N/A	Ramp inside XWalk1?	N/A	N/A	Ramp inside XWalk2?	N/A
	Road Slope (%)	5.8	N/A	Clear Space?	N/A
	Road X Slope (%)	0.8	N/A	Clear Space to XWalk (in)	N/A
N/A	Any Obstructions?	N/A	N/A	Storm Grate/Utility Hazard?	N/A
	Obstruction Type			Storm Grate/Utility Type	
		N/A			N/A
			Yes	Surface Condition? (G/P)	Good

Remove & Replace Curb Ramp With Two New Directional Ramps or Equivalent.
