# Access Compliance Report

## Public Rights-of-Way

### (Curb Ramps)

| Intersection ID: N/A | Main Street: BURNETTE_AV | Cross Street: VILMA_ST | Location: NW |

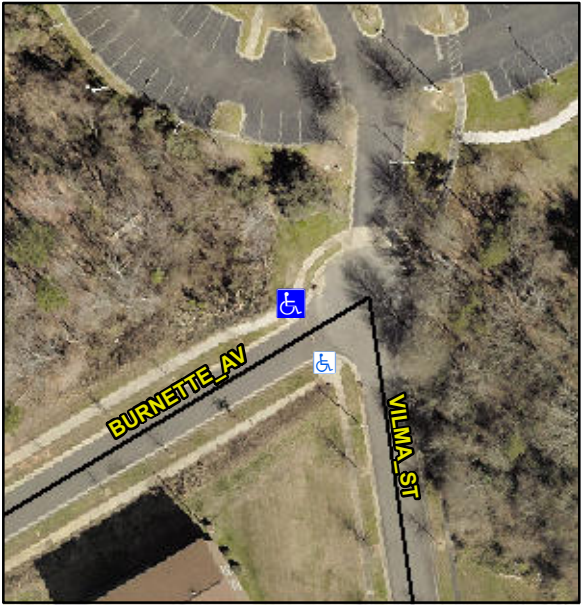
| ADA ID: 2922B8A9DF70 | Ramp Type: Perp | Initial Pass/Fail: Fail | Overall Compliance: No |

| Codes/Mitigation Info/Possible Solution | | | Field Measurements/Component Compliance | | |
|---|---|---|---|---|---|
| | | | <b>No</b> | Ramp Width (in) | <b>47.0</b> |
| <p>Surveyor Notes:</p> <p><b>N/A</b></p> <p>PROW/ADA:</p> <p><b>Not Found, R304.5.1, R304.2.2, R304.5.3</b></p> | | | <b>N/A</b> | Flare Type RT | <b>N/A</b> |

| Codes/Mitigation Info/Possible Solution | | | Field Measurements/Component Compliance | | |
|---|---|---|---|---|---|
| | <b>Remove &amp; Replace Entire Ramp.</b> | | <b>N/A</b> | Ramp Length (in) | <b>47.0</b> |
| Total Cost: | | <b>\$ 1850.00</b> | | Obstruction Type | |
