Access Compliance Report

Public Rights-of-Way

(Curb Ramps)

Intersection ID: 49647	Main Street: STRAWBERRY_LN	Cross Street: GREENBRIAR_HILLS_PLANTATION_RD	Location: SW
ADA ID: 29265618BDFA	Ramp Type: PerpDiag	Initial Pass/Fail: Fail	Overall Compliance: No
Severity Score: 13.75			
Codes/Mitigation Info/Possible Solution		Field Measurements/Component Compliance

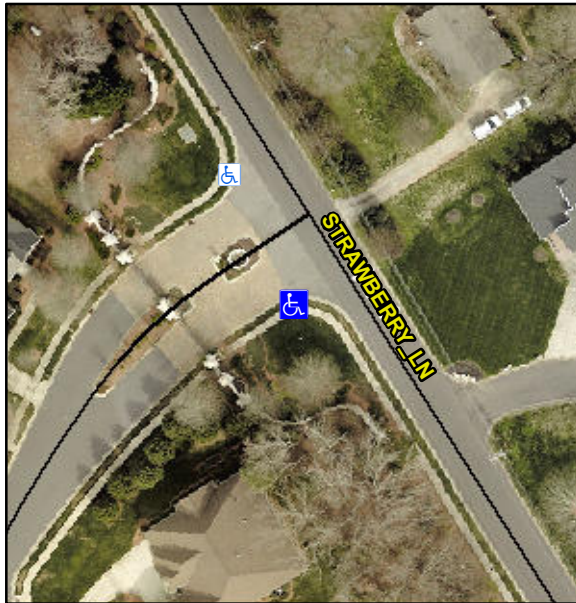
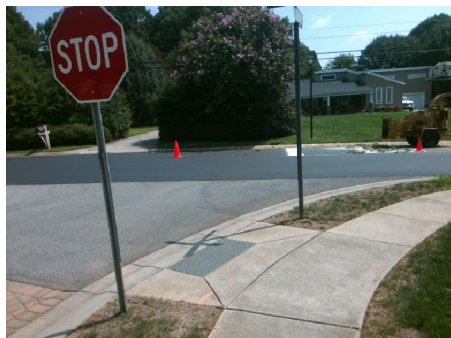
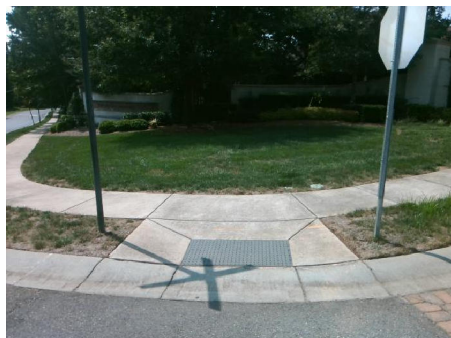
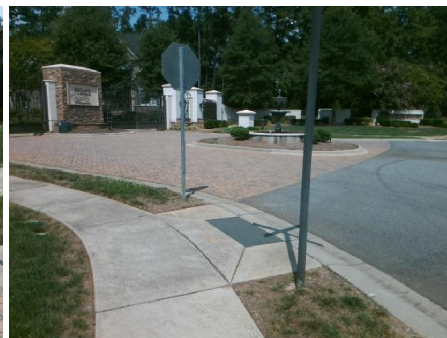
Not Found, R304.2.2, R304.5.3

Compliance	Description	Data	Compliance	Description	Data
N/A	Ramp Length (in)	47.0	No	Ramp Slope (%)	9.1
Yes	Ramp Width (in)	48.0	No	Ramp XSlope (%)	3.2
N/A	Flare Type LT	N/A	N/A	Flare Type RT	N/A
N/A	Flare Slope LT (%)	N/A	N/A	Flare Slope RT (%)	N/A
N/A	Flare Traversable LT?	N/A	N/A	Flare Traversable RT?	N/A
N/A	Landing Length (in)	N/A	N/A	DWS Provided?	N/A
N/A	Landing Width (in)	N/A	N/A	DWS Contrast?	N/A
N/A	Landing Slope (%)	N/A	N/A	DWS Length (in)	N/A
N/A	Landing X Slope (%)	N/A	N/A	DWS Full Width?	N/A
N/A	Landing Curb? (Y/N)	N/A	N/A	DWS Offset (in)	N/A
N/A	Shared Landing?	N/A			
N/A	Gutter Ponding?	N/A	N/A	Gutter Slope (%)	N/A
N/A	Gutter Lip Ht (in)	N/A	N/A	Gutter X Slope (%)	N/A
N/A	Painted X Walk1?	No	N/A	Painted X Walk2?	No
	X Walk 1 Direction	To NE		X Walk 2 Direction	To N
N/A	X Walk 1 Width (in)	N/A	N/A	X Walk 2 Width (in)	N/A
	X Walk 1 Slope (%)	3.3		X Walk 2 Slope (%)	6.1
	X Walk 1 X Slope (%)	5.2		X Walk 2 X Slope (%)	2.2

N/A	Ramp inside XWalk1?	N/A	N/A	Ramp inside XWalk2?	N/A
	Road Slope (%)	3.2	N/A	Clear Space?	N/A
	Road X Slope (%)	3.8	N/A	Clear Space to XWalk (in)	N/A
N/A	Any Obstructions?	N/A	N/A	Storm Grate/Utility Hazard?	N/A
	Obstruction Type			Storm Grate/Utility Type	
		N/A			N/A
			Yes	Surface Condition? (G/P)	Good

Remove & Replace Curb Ramp With Two New Directional Ramps or Equivalent.
