# Access Compliance Report

## Public Rights-of-Way

### (Curb Ramps)

Intersection ID: 4775	Main Street: OLD_STATESVILLE_RD	Cross Street: HENDERSON_CR	Location: NW
ADA ID: 292A24640558	Ramp Type: Perp	Initial Pass/Fail: Fail	Overall Compliance: No
		Severity Score: 35

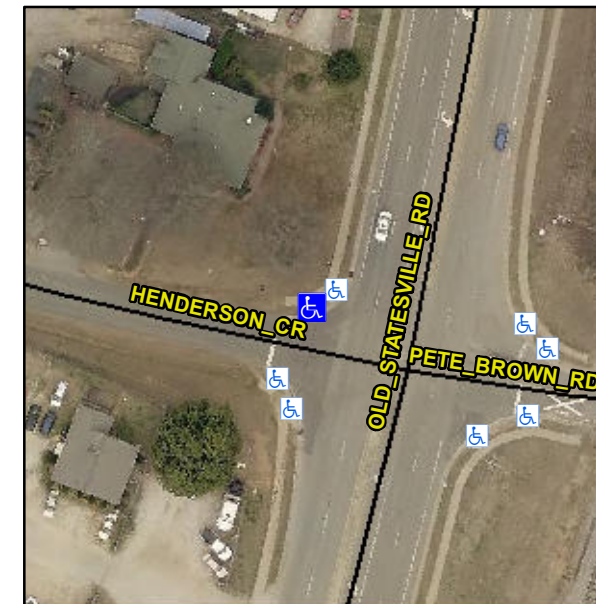
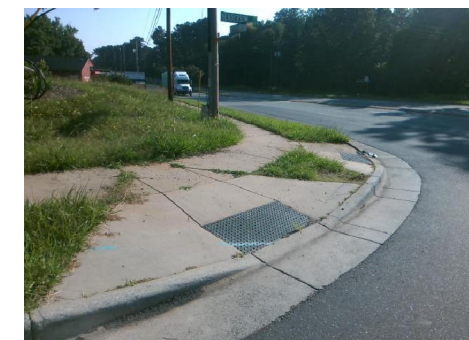
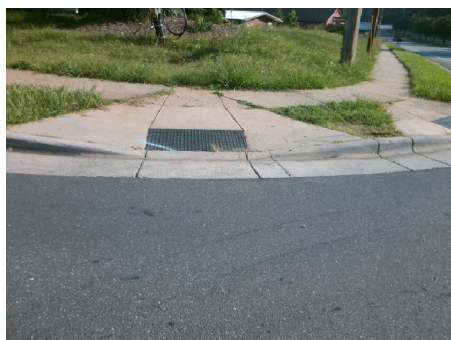
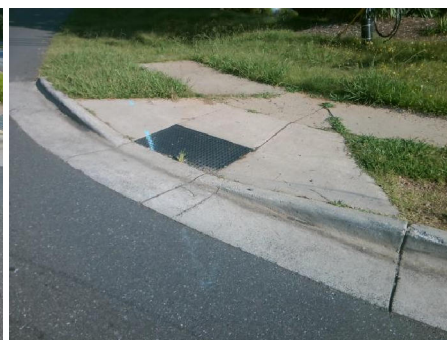
**Not Found, R304.5.1, R304.2.2, R304.5.3**

Compliance	Description	Data	Compliance	Description	Data
N/A	Ramp Length (in)	60.0	No	Ramp Slope (%)	13.4
No	Ramp Width (in)	38.0	No	Ramp XSlope (%)	2.1
N/A	Flare Type LT	N/A	N/A	Flare Type RT	N/A
N/A	Flare Slope LT (%)	N/A	N/A	Flare Slope RT (%)	N/A
N/A	Flare Traversable LT?	N/A	N/A	Flare Traversable RT?	N/A
N/A	Landing Length (in)	N/A	N/A	DWS Provided?	N/A
N/A	Landing Width (in)	N/A	N/A	DWS Contrast?	N/A
N/A	Landing Slope (%)	N/A	N/A	DWS Length (in)	N/A
N/A	Landing X Slope (%)	N/A	N/A	DWS Full Width?	N/A
N/A	Landing Curb? (Y/N)	N/A	N/A	DWS Offset (in)	N/A
N/A	Shared Landing?	N/A			
N/A	Gutter Ponding?	N/A	N/A	Gutter Slope (%)	N/A
N/A	Gutter Lip Ht (in)	0.5	N/A	Gutter X Slope (%)	N/A
N/A	Painted X Walk1?	No	N/A	Painted X Walk2?	N/A
	X Walk 1 Direction	To W		X Walk 2 Direction	N/A
N/A	X Walk 1 Width (in)	N/A	N/A	X Walk 2 Width (in)	N/A
	X Walk 1 Slope (%)	2.9		X Walk 2 Slope (%)	N/A
	X Walk 1 X Slope (%)	2.6		X Walk 2 X Slope (%)	N/A

N/A	Ramp inside XWalk1?	N/A	N/A	Ramp inside XWalk2?	N/A
	Road Slope (%)	N/A	N/A	Clear Space?	N/A
	Road X Slope (%)	N/A	N/A	Clear Space to XWalk (in)	N/A
N/A	Any Obstructions?	N/A	N/A	Storm Grate/Utility Hazard?	N/A
	Obstruction Type			Storm Grate/Utility Type	
		N/A			N/A
			Yes	Surface Condition? (G/P)	Good

**Remove & Replace Entire Ramp.**
