Access Compliance Report

Public Rights-of-Way

(Curb Ramps)

Intersection ID: 26775	Main Street: CREEK_BEND_DR	Cross Street: ELM_CREEK_LN	Location: SW
ADA ID: 292F44620D27	Ramp Type: PerpDiag	Initial Pass/Fail: Fail	Overall Compliance: No
			Severity Score: 18.75

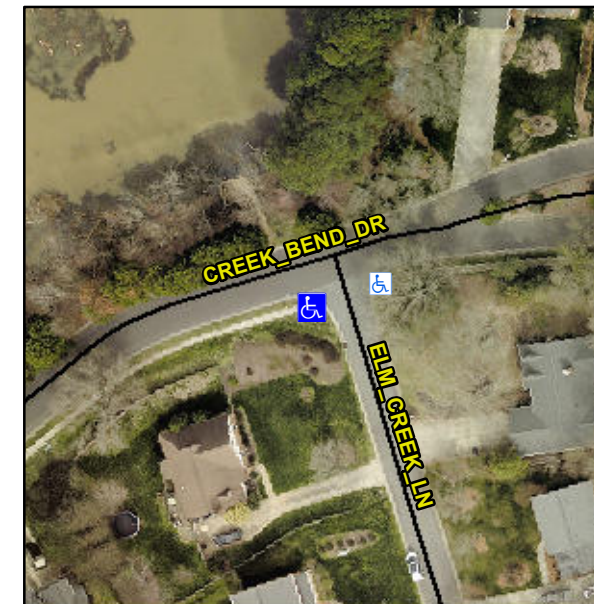
Not Found, R304.5.1, R304.5.3

Compliance	Description	Data	Compliance	Description	Data
N/A	Ramp Length (in)	92.0	Yes	Ramp Slope (%)	5.9
No	Ramp Width (in)	33.0	No	Ramp XSlope (%)	3.9
N/A	Flare Type LT	N/A	N/A	Flare Type RT	N/A
N/A	Flare Slope LT (%)	N/A	N/A	Flare Slope RT (%)	N/A
N/A	Flare Traversable LT?	N/A	N/A	Flare Traversable RT?	N/A
N/A	Landing Length (in)	N/A	N/A	DWS Provided?	N/A
N/A	Landing Width (in)	N/A	N/A	DWS Contrast?	N/A
N/A	Landing Slope (%)	N/A	N/A	DWS Length (in)	N/A
N/A	Landing X Slope (%)	N/A	N/A	DWS Full Width?	N/A
N/A	Landing Curb? (Y/N)	N/A	N/A	DWS Offset (in)	N/A
N/A	Shared Landing?	N/A			
N/A	Gutter Ponding?	N/A	N/A	Gutter Slope (%)	N/A
N/A	Gutter Lip Ht (in)	N/A	N/A	Gutter X Slope (%)	N/A
N/A	Painted X Walk1?	No	N/A	Painted X Walk2?	No
	X Walk 1 Direction	To E		X Walk 2 Direction	To N
N/A	X Walk 1 Width (in)	N/A	N/A	X Walk 2 Width (in)	N/A
	X Walk 1 Slope (%)	2.3		X Walk 2 Slope (%)	1.2
	X Walk 1 X Slope (%)	0.1		X Walk 2 X Slope (%)	3.5

N/A	Ramp inside XWalk1?	N/A	N/A	Ramp inside XWalk2?	N/A
	Road Slope (%)	1.6	N/A	Clear Space?	N/A
	Road X Slope (%)	2.3	N/A	Clear Space to XWalk (in)	N/A
N/A	Any Obstructions?	N/A	N/A	Storm Grate/Utility Hazard?	N/A
	Obstruction Type			Storm Grate/Utility Type	
		N/A			N/A
			Yes	Surface Condition? (G/P)	Good

Remove & Replace Curb Ramp With Two New Directional Ramps or Equivalent.
