# Access Compliance Report

## Public Rights-of-Way

### (Curb Ramps)

Intersection ID: 14714	Main Street: E_MOREHEAD_ST	Cross Street: HARDING_PL	Location: S
ADA ID: 293611700B79	Ramp Type: Perp	Initial Pass/Fail: Fail	Overall Compliance: No
Severity Score: 12.5			
Codes/Mitigation Info/Possible Solution		Field Measurements/Component Compliance

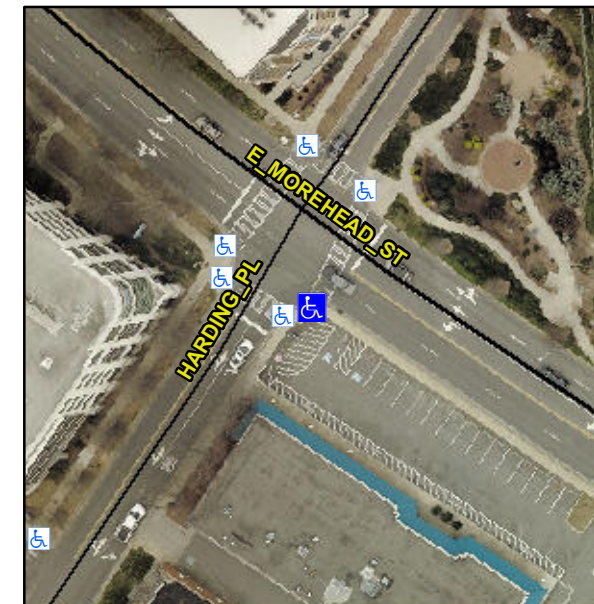
**Not Found, R304.2.2**

Compliance	Description	Data	Compliance	Description	Data
N/A	Ramp Length (in)	36.0	No	Ramp Slope (%)	9.7
Yes	Ramp Width (in)	48.0	Yes	Ramp XSlope (%)	0.5
N/A	Flare Type LT	N/A	N/A	Flare Type RT	N/A
N/A	Flare Slope LT (%)	N/A	N/A	Flare Slope RT (%)	N/A
N/A	Flare Traversable LT?	N/A	N/A	Flare Traversable RT?	N/A
N/A	Landing Length (in)	N/A	N/A	DWS Provided?	N/A
N/A	Landing Width (in)	N/A	N/A	DWS Contrast?	N/A
N/A	Landing Slope (%)	N/A	N/A	DWS Length (in)	N/A
N/A	Landing X Slope (%)	N/A	N/A	DWS Full Width?	N/A
N/A	Landing Curb? (Y/N)	N/A	N/A	DWS Offset (in)	N/A
N/A	Shared Landing?	N/A			
N/A	Gutter Ponding?	N/A	N/A	Gutter Slope (%)	N/A
N/A	Gutter Lip Ht (in)	N/A	N/A	Gutter X Slope (%)	N/A
N/A	Painted X Walk1?	Yes	N/A	Painted X Walk2?	N/A
	X Walk 1 Direction	To NE		X Walk 2 Direction	N/A
N/A	X Walk 1 Width (in)	111.0	N/A	X Walk 2 Width (in)	N/A
	X Walk 1 Slope (%)	1.1		X Walk 2 Slope (%)	N/A
	X Walk 1 X Slope (%)	2.9		X Walk 2 X Slope (%)	N/A

**Remove & Replace Entire Ramp.**
