Intersection ID: 8391	Main Street: LASALLE_ST	Cross Street: MADRID_ST	Location:	NE
ADA ID: 293D1F419E25	Ramp Type: PerpDiag	Initial Pass/Fail: Fail	Overall Compliance: No	Severity Score: 21.25

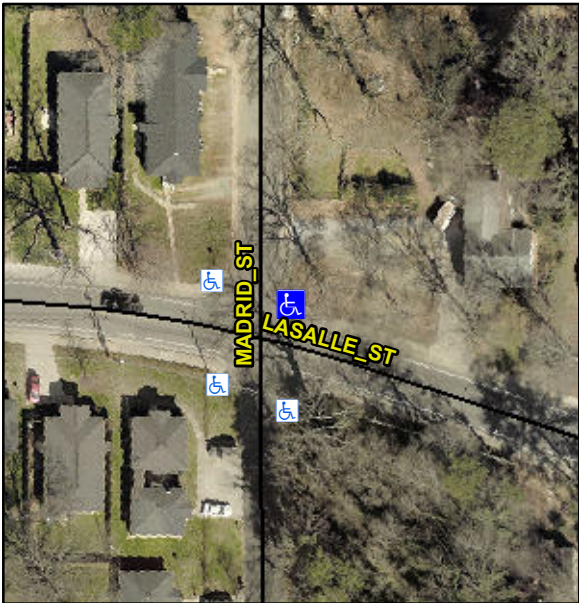
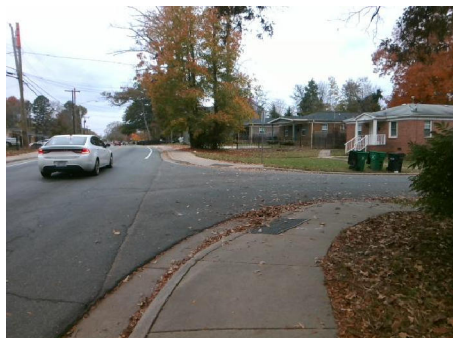
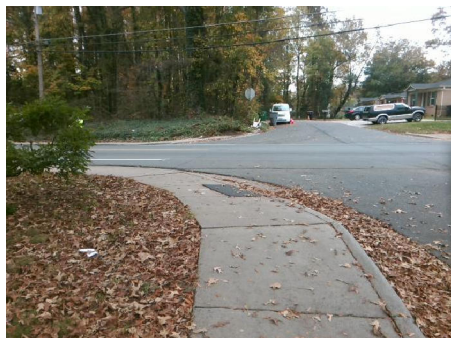
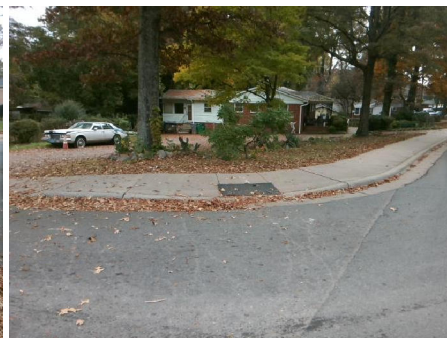
Possible Solutions:		<b>Remove &amp; Replace Curb Ramp With Two New Directional Ramps or Equivalent.</b>	<b>Compliance</b>	<b>Description</b>	<b>Data</b>	<b>Compliance</b>	<b>Description</b>	<b>Data</b>
	Surveyor Notes:		<b>N/A</b>	<b>N/A</b>	Ramp Length (in)	<b>60.0</b>	<b>No</b>	Ramp Slope (%)	<b>10.4</b>
	PROW/ADA:		<b>Not Found, R304.5.1, R304.2.2</b>	<b>No</b>	Ramp Width (in)	<b>41.0</b>	<b>Yes</b>	Ramp XSlope (%)	<b>0.4</b>
				<b>N/A</b>	Flare Type LT	<b>N/A</b>	<b>N/A</b>	Flare Type RT	<b>N/A</b>
				<b>N/A</b>	Flare Slope LT (%)	<b>N/A</b>	<b>N/A</b>	Flare Slope RT (%)	<b>N/A</b>
				<b>N/A</b>	Flare Traversable LT?	<b>N/A</b>	<b>N/A</b>	Flare Traversable RT?	<b>N/A</b>
				<b>N/A</b>	Landing Length (in)	<b>N/A</b>	<b>N/A</b>	DWS Provided?	<b>N/A</b>
				<b>N/A</b>	Landing Width (in)	<b>N/A</b>	<b>N/A</b>	DWS Contrast?	<b>N/A</b>

<b>N/A</b>	Landing Slope (%)	<b>N/A</b>	<b>N/A</b>	DWS Length (in)	<b>N/A</b>
				<b>N/A</b>	Landing X Slope (%)	<b>N/A</b>	<b>N/A</b>	DWS Full Width?	<b>N/A</b>
				<b>N/A</b>	Landing Curb? (Y/N)	<b>N/A</b>	<b>N/A</b>	DWS Offset (in)	<b>N/A</b>
				<b>N/A</b>	Shared Landing?	<b>N/A</b>			
				<b>N/A</b>	Gutter Ponding?	<b>N/A</b>	<b>N/A</b>	Gutter Slope (%)	<b>N/A</b>
				<b>N/A</b>	Gutter Lip Ht (in)	<b>1.0</b>	<b>N/A</b>	Gutter X Slope (%)	<b>N/A</b>
				<b>N/A</b>	Painted X Walk1?	<b>No</b>	<b>N/A</b>	Painted X Walk2?	<b>No</b>
					X Walk 1 Direction	<b>To W</b>		X Walk 2 Direction	<b>To S</b>
				<b>N/A</b>	X Walk 1 Width (in)	<b>N/A</b>	<b>N/A</b>	X Walk 2 Width (in)	<b>N/A</b>
					X Walk 1 Slope (%)	<b>2.2</b>		X Walk 2 Slope (%)	<b>0.2</b>
					X Walk 1 X Slope (%)	<b>4.5</b>		X Walk 2 X Slope (%)	<b>3.7</b>
				<b>N/A</b>	Ramp inside XWalk1?	<b>N/A</b>	<b>N/A</b>	Ramp inside XWalk2?	<b>N/A</b>

Road Slope (%)	<b>0.7</b>	<b>N/A</b>	Clear Space?	<b>N/A</b>
					Road X Slope (%)	<b>5.5</b>	<b>N/A</b>	Clear Space to XWalk (in)	<b>N/A</b>
				<b>N/A</b>	Any Obstructions?	<b>N/A</b>	<b>N/A</b>	Storm Grate/Utility Hazard?	<b>N/A</b>
					Obstruction Type			Storm Grate/Utility Type	
						<b>N/A</b>			<b>N/A</b>
							<b>Yes</b>	Surface Condition? (G/P)	<b>Good</b>
				Total Cost:	\$	<b>3200.00</b>
