Access Compliance Report

Public Rights-of-Way (Curb Ramps)

Intersection ID: 10096	Main Street: SELDON_DR	Cross Street: W_TRADE_ST	Location: S
ADA ID: 293F48850351	Ramp Type: Perp	Initial Pass/Fail: Fail	Overall Compliance: No
		Severity Score: 22.5

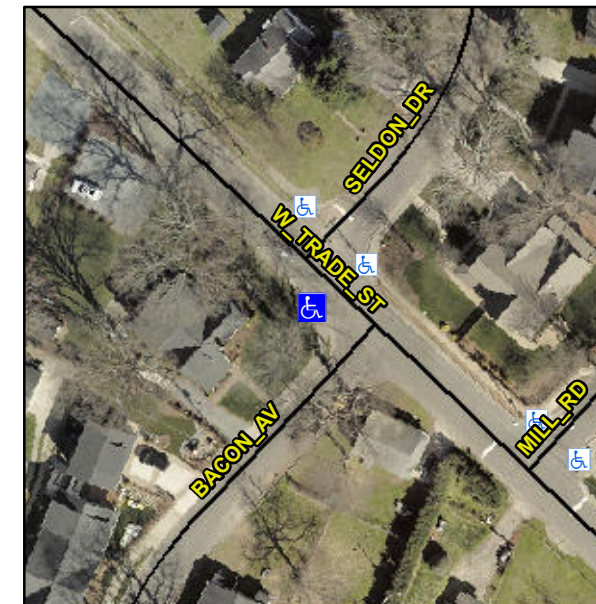
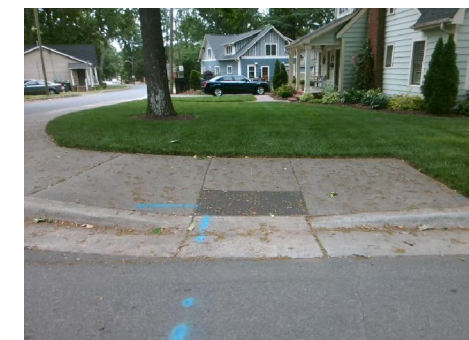
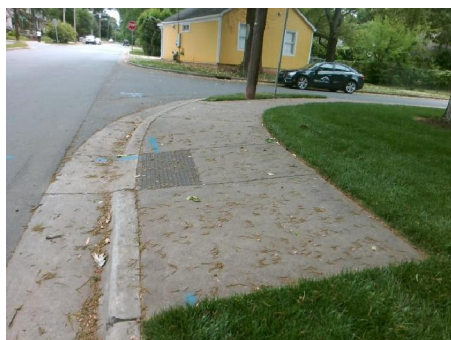
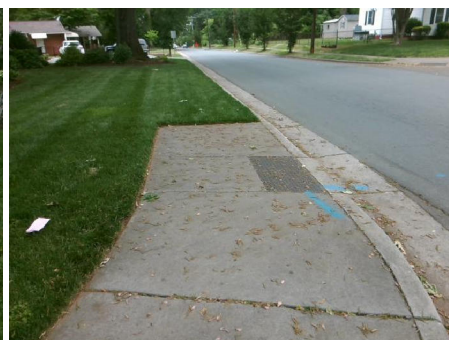
**Not Found, R304.5.1, R304.2.2,
R304.5.3**

Compliance	Description	Data	Compliance	Description	Data
N/A	Ramp Length (in)	74.0	No	Ramp Slope (%)	8.9
No	Ramp Width (in)	47.0	No	Ramp XSlope (%)	3.0
N/A	Flare Type LT	N/A	N/A	Flare Type RT	N/A
N/A	Flare Slope LT (%)	N/A	N/A	Flare Slope RT (%)	N/A
N/A	Flare Traversable LT?	N/A	N/A	Flare Traversable RT?	N/A
N/A	Landing Length (in)	N/A	N/A	DWS Provided?	N/A
N/A	Landing Width (in)	N/A	N/A	DWS Contrast?	N/A
N/A	Landing Slope (%)	N/A	N/A	DWS Length (in)	N/A
N/A	Landing X Slope (%)	N/A	N/A	DWS Full Width?	N/A
N/A	Landing Curb? (Y/N)	N/A	N/A	DWS Offset (in)	N/A
N/A	Shared Landing?	N/A			
N/A	Gutter Ponding?	N/A	N/A	Gutter Slope (%)	N/A
N/A	Gutter Lip Ht (in)	N/A	N/A	Gutter X Slope (%)	N/A
N/A	Painted X Walk1?	No	N/A	Painted X Walk2?	N/A
	X Walk 1 Direction	To NE		X Walk 2 Direction	N/A
N/A	X Walk 1 Width (in)	N/A	N/A	X Walk 2 Width (in)	N/A
	X Walk 1 Slope (%)	2.2		X Walk 2 Slope (%)	N/A
	X Walk 1 X Slope (%)	2.9		X Walk 2 X Slope (%)	N/A

N/A	Ramp inside XWalk1?	N/A	N/A	Ramp inside XWalk2?	N/A
	Road Slope (%)	N/A	N/A	Clear Space?	N/A
	Road X Slope (%)	N/A	N/A	Clear Space to XWalk (in)	N/A
N/A	Any Obstructions?	N/A	N/A	Storm Grate/Utility Hazard?	N/A
	Obstruction Type			Storm Grate/Utility Type	
		N/A			N/A
			Yes	Surface Condition? (G/P)	Good

Remove & Replace Entire Ramp.
