Access Compliance Report

Public Rights-of-Way

(Curb Ramps)

Intersection ID: 23663	Main Street: S_TRYON_ST	Cross Street: ERWIN_RD	Location: N
ADA ID: 2943CC4E1C01	Ramp Type: PerpDiag	Initial Pass/Fail: Fail	Overall Compliance: No
Severity Score: 12.5			
Codes/Mitigation Info/Possible Solution		Field Measurements/Component Compliance

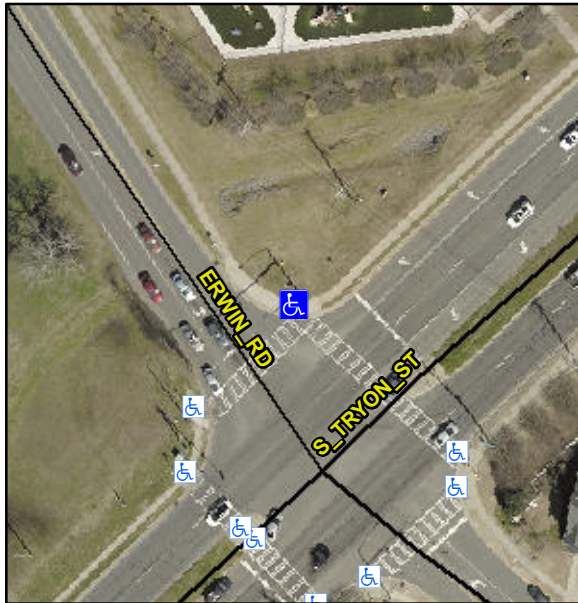
Not Found, R304.2.2

Compliance	Description	Data	Compliance	Description	Data
N/A	Ramp Length (in)	41.0	No	Ramp Slope (%)	10.5
Yes	Ramp Width (in)	48.0	Yes	Ramp XSlope (%)	1.1
N/A	Flare Type LT	N/A	N/A	Flare Type RT	N/A
N/A	Flare Slope LT (%)	N/A	N/A	Flare Slope RT (%)	N/A
N/A	Flare Traversable LT?	N/A	N/A	Flare Traversable RT?	N/A
N/A	Landing Length (in)	N/A	N/A	DWS Provided?	N/A
N/A	Landing Width (in)	N/A	N/A	DWS Contrast?	N/A
N/A	Landing Slope (%)	N/A	N/A	DWS Length (in)	N/A
N/A	Landing X Slope (%)	N/A	N/A	DWS Full Width?	N/A
N/A	Landing Curb? (Y/N)	N/A	N/A	DWS Offset (in)	N/A
N/A	Shared Landing?	N/A			
N/A	Gutter Ponding?	N/A	N/A	Gutter Slope (%)	N/A
N/A	Gutter Lip Ht (in)	N/A	N/A	Gutter X Slope (%)	N/A
N/A	Painted X Walk1?	Yes	N/A	Painted X Walk2?	Yes
	X Walk 1 Direction	To SW		X Walk 2 Direction	To SE
N/A	X Walk 1 Width (in)	120.0	N/A	X Walk 2 Width (in)	111.0
	X Walk 1 Slope (%)	1.9		X Walk 2 Slope (%)	1.8
	X Walk 1 X Slope (%)	1.3		X Walk 2 X Slope (%)	0.2

N/A	Ramp inside XWalk1?	Yes	N/A	Ramp inside XWalk2?	Yes
	Road Slope (%)	0.3	N/A	Clear Space?	N/A
	Road X Slope (%)	1.0	N/A	Clear Space to XWalk (in)	N/A
N/A	Any Obstructions?	N/A	N/A	Storm Grate/Utility Hazard?	N/A
	Obstruction Type			Storm Grate/Utility Type	
		N/A			N/A
		Yes		Surface Condition? (G/P)	Good

Possible Solutions:

Remove & Replace Curb Ramp With Two New Directional Ramps or Equivalent.
