Access Compliance Report

Public Rights-of-Way

(Curb Ramps)

Intersection ID: 12027	Main Street: S_SUMMIT_AV	Cross Street: W_MOREHEAD_ST	Location: NW
ADA ID: 29501CDDDB238	Ramp Type: Perp	Initial Pass/Fail: Fail	Overall Compliance: No
		Severity Score: 8.75

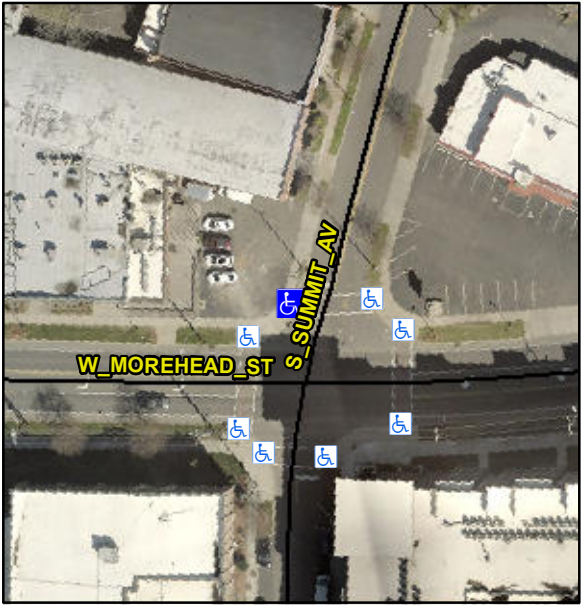
Possible Solutions:		Compliance	Description	Data
	Remove & Replace Entire Ramp.		Yes	Ramp Length (in)	84.0
			No	Ramp Width (in)	47.5
			N/A	Flare Type LT	N/A
			N/A	Flare Slope LT (%)	N/A
			N/A	Flare Traversable LT?	N/A
			N/A	Landing Length (in)	N/A
			N/A	Landing Width (in)	N/A
			N/A	Landing Slope (%)	N/A
			N/A	Landing X Slope (%)	N/A
<p>Surveyor Notes:</p> <p>N/A</p>			N/A	Landing Curb? (Y/N)	N/A
			N/A	Shared Landing?	N/A
			N/A	Gutter Ponding?	N/A
			N/A	Gutter Lip Ht (in)	N/A
			N/A	Painted X Walk1?	Yes
			N/A	X Walk 1 Direction	To E
			N/A	X Walk 1 Width (in)	103.5
			N/A	X Walk 1 Slope (%)	5.1
			N/A	X Walk 1 X Slope (%)	0.2
			N/A	Ramp inside XWalk1?	Yes
<p>PROW/ADA:</p> <p>Not Found, R304.5.1</p>			N/A	Road Slope (%)	N/A
			N/A	Road X Slope (%)	N/A
			N/A	Any Obstructions?	N/A
			N/A	Obstruction Type	
			N/A		
			N/A

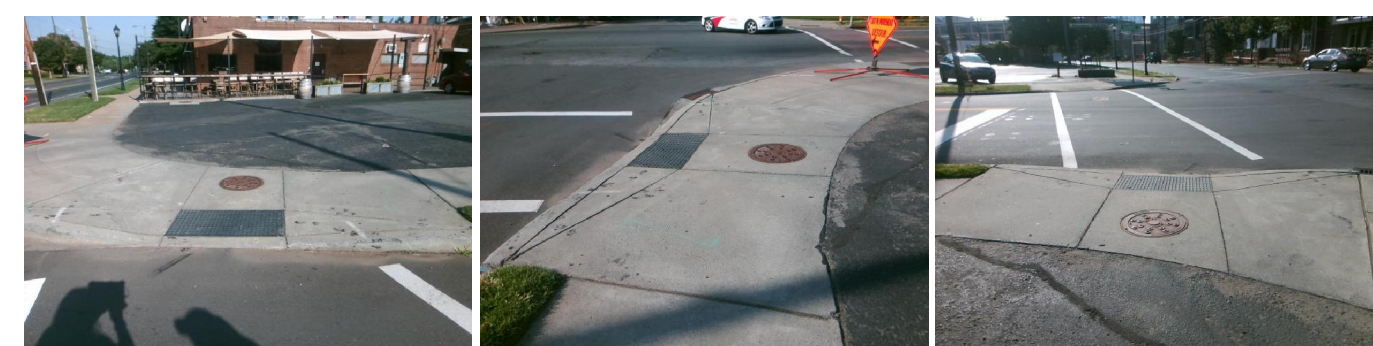
N/A		
			N/A		
			N/A		
			N/A		
<p>Street 1 Name</p> <p>Stop Condition-Street 2</p> <p>Street 2 Name</p> <p>Stop Condition-Street 1</p>			N/A	Storm Grate/Utility Hazard?	N/A
			N/A	Storm Grate/Utility Type	
			N/A		
			N/A		
			N/A		
			N/A		
			N/A		
			N/A		
			N/A		
			N/A		
<p>Total Cost:</p> <p>\$ 1850.00</p>			Yes	Surface Condition? (G/P)	Good
