## **Access Compliance Report Public Rights-of-Way** (Curb Ramps)

Intersection ID: 11581 Main Street: E\_17TH\_ST Cross Street: N\_DAVIDSON\_ST Location: N ADA ID: 2954CF42A534 Ramp Type: PerpDiag Initial Pass/Fail: Fail **Overall Compliance: No Severity Score:** 25

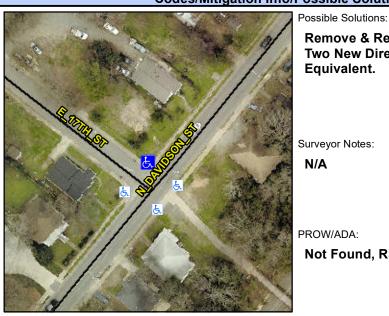
Not Found, R304.2.2, R304.5.3

Compliance Description		Data	Compliance Description		Data
N/A	Ramp Length (in)	60.0	No	Ramp Slope (%)	9.4
Yes	Ramp Width (in)	54.0	No	Ramp XSlope (%)	5.5
N/A	Flare Type LT	N/A	N/A	Flare Type RT	N/A
N/A	Flare Slope LT (%)	N/A	N/A	Flare Slope RT (%)	N/A
N/A	Flare Traversable LT?	N/A	N/A	Flare Traversable RT?	N/A
N/A	Landing Length (in)	N/A	N/A	DWS Provided?	N/A
N/A	Landing Width (in)	N/A	N/A	DWS Contrast?	N/A
N/A	Landing Slope (%)	N/A	N/A	DWS Length (in)	N/A
N/A	Landing X Slope (%)	N/A	N/A	DWS Full Width?	N/A
N/A	Landing Curb? (Y/N)	N/A	N/A	DWS Offset (in)	N/A
N/A	Shared Landing?	N/A			
N/A	Gutter Ponding?	N/A	N/A	Gutter Slope (%)	N/A
N/A	Gutter Lip Ht (in)	N/A	N/A	Gutter X Slope (%)	N/A
N/A	Painted X Walk1?	No	N/A	Painted X Walk2?	No
	X Walk 1 Direction	To SW		X Walk 2 Direction	To SE
N/A	X Walk 1 Width (in)	N/A	N/A	X Walk 2 Width (in)	N/A
	X Walk 1 Slope (%)	1.4		X Walk 2 Slope (%)	3.4
	X Walk 1 X Slope (%)	5.7		X Walk 2 X Slope (%)	3.3

N/A	Ramp inside XWalk1?	N/A	N/A	Ramp inside XWalk2?	N/A
	Road Slope (%)	5.8	N/A	Clear Space?	N/A
	Road X Slope (%)	0.7	N/A	Clear Space to XWalk (in)	N/A
N/A	Any Obstructions?	N/A	N/A	Storm Grate/Utility Hazard?	N/A
	Obstruction Type			Storm Grate/Utility Type	
		N/A			N/A

Remove & Replace Curb Ramp With **Two New Directional Ramps or** Equivalent.

3200.00
