# Access Compliance Report

## Public Rights-of-Way

| Intersection ID: 23663 | Main Street: S_TRYON_ST | Cross Street: ERWIN_RD | Location: W |
| ADA ID: 296763C550F3 | Ramp Type: MedianPerp | Initial Pass/Fail: Fail | Overall Compliance: No |

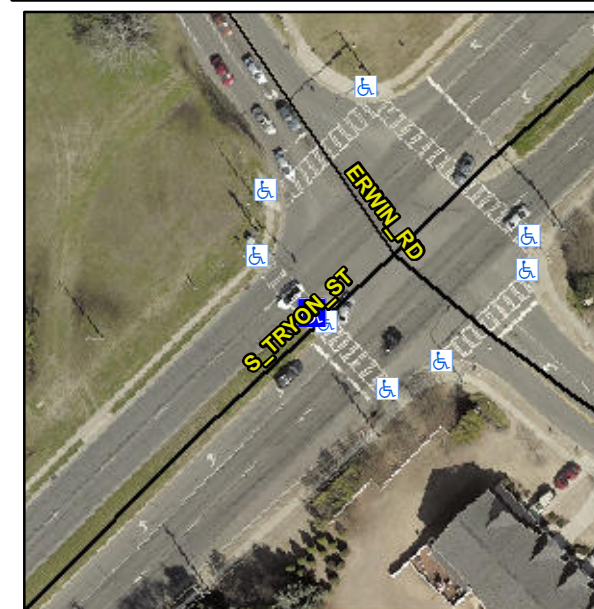
| Severity Score: 8.75 | | | |

**Not Found, R304.5.1**

| Compliance | Description | Data | Compliance | Description | Data |
|---|---|---|---|---|---|
| No | Ramp Width (in) | 47.0 | Yes | Ramp XSlope (%) | 1.4 |

**Remove & Replace Entire Ramp.**

Total Cost: \$ 1650.00
