Access Compliance Report

Public Rights-of-Way

(Curb Ramps)

Intersection ID: N/A	Main Street: NINA_DR	Cross Street: W_T_HARRIS_BV	Location: NE
ADA ID: 296886A50F69	Ramp Type: PerpDiag	Initial Pass/Fail: Fail	Overall Compliance: No
Codes/Mitigation Info/Possible Solution		Field Measurements/Component Compliance

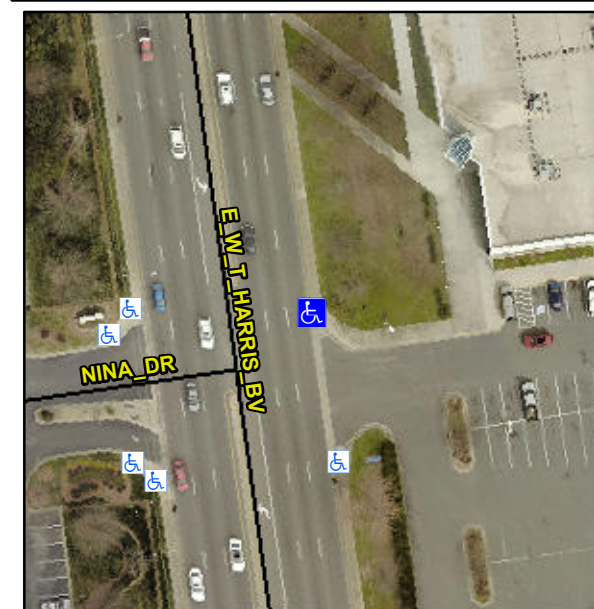
R304.2.2, R304.5.3

Compliance	Description	Data	Compliance	Description	Data
N/A	Ramp Length (in)	61.0	No	Ramp Slope (%)	11.1
Yes	Ramp Width (in)	54.0	No	Ramp XSlope (%)	3.8
N/A	Flare Type LT	N/A	N/A	Flare Type RT	N/A
N/A	Flare Slope LT (%)	N/A	N/A	Flare Slope RT (%)	N/A
N/A	Flare Traversable LT?	N/A	N/A	Flare Traversable RT?	N/A
N/A	Landing Length (in)	N/A	N/A	DWS Provided?	N/A
N/A	Landing Width (in)	N/A	N/A	DWS Contrast?	N/A
N/A	Landing Slope (%)	N/A	N/A	DWS Length (in)	N/A
N/A	Landing X Slope (%)	N/A	N/A	DWS Full Width?	N/A
N/A	Landing Curb? (Y/N)	N/A	N/A	DWS Offset (in)	N/A
N/A	Shared Landing?	N/A			
N/A	Gutter Ponding?	N/A	N/A	Gutter Slope (%)	N/A
N/A	Gutter Lip Ht (in)	N/A	N/A	Gutter X Slope (%)	N/A
N/A	Painted X Walk1?	No	N/A	Painted X Walk2?	No
	X Walk 1 Direction	To W		X Walk 2 Direction	To S
N/A	X Walk 1 Width (in)	N/A	N/A	X Walk 2 Width (in)	N/A
	X Walk 1 Slope (%)	0.9		X Walk 2 Slope (%)	0.8
	X Walk 1 X Slope (%)	1.1		X Walk 2 X Slope (%)	4.4

N/A	Ramp inside XWalk1?	N/A	N/A	Ramp inside XWalk2?	N/A
	Road Slope (%)	2.7	N/A	Clear Space?	N/A
	Road X Slope (%)	3.1	N/A	Clear Space to XWalk (in)	N/A
N/A	Any Obstructions?	N/A	N/A	Storm Grate/Utility Hazard?	N/A
	Obstruction Type			Storm Grate/Utility Type	
		N/A			N/A
			Yes	Surface Condition? (G/P)	Good

Remove & Replace Curb Ramp With Two New Directional Ramps or Equivalent.
