# Access Compliance Report

## Public Rights-of-Way

### (Curb Ramps)

Intersection ID: 13151	Main Street: MERRIMAN_AV	Cross Street: SPRUCE_ST	Location: SW
ADA ID: 296DFB01277F	Ramp Type: ParaDiag	Initial Pass/Fail: Fail	Overall Compliance: No
Codes/Mitigation Info/Possible Solution		Field Measurements/Component Compliance	
Severity Score: 12.5

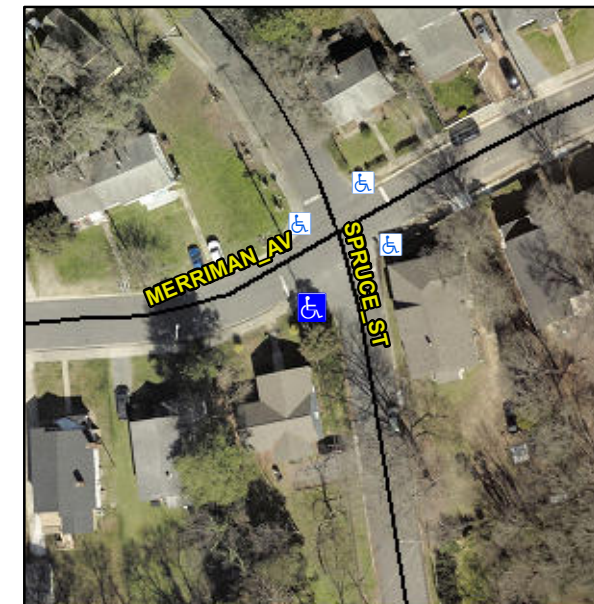
**RT RP < 5%**

**R304.3.2**

Compliance	Description	Data	Compliance	Description	Data
N/A	Ramp Length LT (in)	62.0	N/A	Ramp Length RT (in)	54.0
Yes	Ramp Width LT (in)	59.0	Yes	Ramp Width RT (in)	60.0
No	Ramp Slope LT (%)	9.4	Yes	Ramp Slope RT (%)	1.2
Yes	Ramp XSlope LT (%)	1.8	Yes	Ramp XSlope RT (%)	1.5
N/A	Landing Length (in)	N/A	N/A	DWS Provided?	N/A
N/A	Landing Width (in)	N/A	N/A	DWS Contrast?	N/A
N/A	Landing Slope (%)	N/A	N/A	DWS Length (in)	N/A
N/A	Landing X Slope (%)	N/A	N/A	DWS Full Width?	N/A
N/A	Landing Curb? (Y/N)	N/A	N/A	DWS Offset (in)	N/A
N/A	Shared Landing?	N/A			
N/A	Gutter Ponding?	N/A	N/A	Gutter Slope (%)	N/A
N/A	Gutter Lip Ht (in)	N/A	N/A	Gutter X Slope (%)	N/A
N/A	Painted X Walk1?	No	N/A	Painted X Walk2?	No
	X Walk 1 Direction	To NE		X Walk 2 Direction	To NW
N/A	X Walk 1 Width (in)	N/A	N/A	X Walk 2 Width (in)	N/A
	X Walk 1 Slope (%)	4.9		X Walk 2 Slope (%)	2.0
	X Walk 1 X Slope (%)	0.6		X Walk 2 X Slope (%)	1.4
N/A	Ramp inside XWalk1?	N/A	N/A	Ramp inside XWalk2?	N/A

Road Slope (%)	1.2	N/A	Clear Space?	N/A
	Road X Slope (%)	3.4	N/A	Clear Space to XWalk (in)	N/A
N/A	Any Obstructions?	N/A	N/A	Storm Grate/Utility Hazard?	N/A
	Obstruction Type			Storm Grate/Utility Type	
		N/A			N/A
			Yes	Surface Condition? (G/P)	Good
			N/A	Curb Slope (%)	14.8

**Remove & Replace Curb Ramp With Two New Directional Ramps or Equivalent.**

Total Cost: \$ 3200.00
