# Access Compliance Report

## Public Rights-of-Way

### (Curb Ramps)

Intersection ID: 6462	Main Street: BURGANDY_DR	Cross Street: MINERAL_SPRINGS_RD	Location: SE
ADA ID: 297A903F0560	Ramp Type: BlendTrans1	Initial Pass/Fail: Fail	Overall Compliance: No
Severity Score: 1.25			
Codes/Mitigation Info/Possible Solution		Field Measurements/Component Compliance

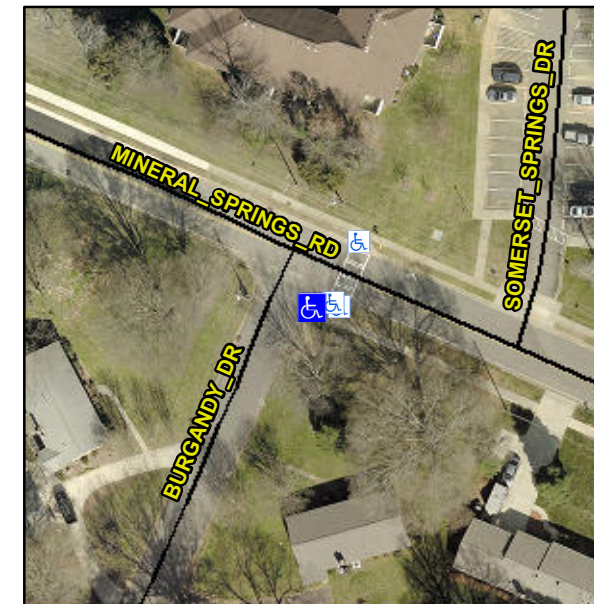
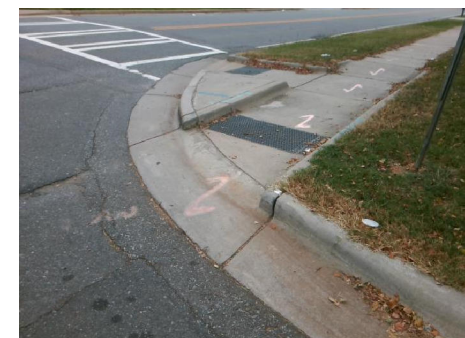
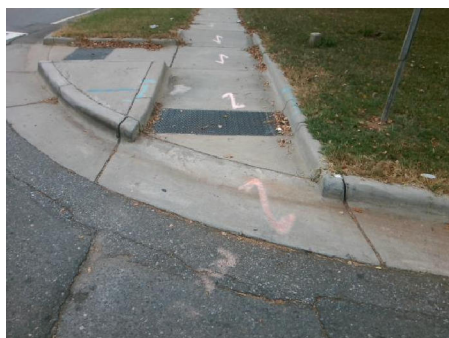
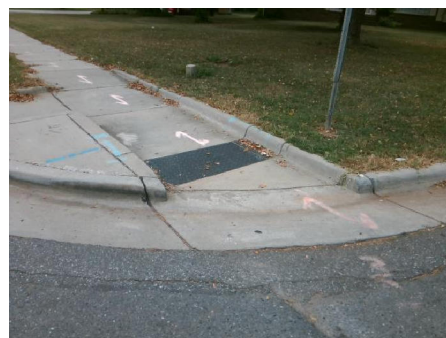
**Not Found, R304.5.3**

Compliance	Description	Data	Compliance	Description	Data
N/A	Ramp Length (in)	89.0	Yes	BlendTrans Slope (%)	1.5
Yes	Ramp Width (in)	55.0	No	BlendTrans XSlope (%)	2.6
N/A	Flare Type LT	N/A	N/A	Flare Type RT	N/A
N/A	Flare Slope LT (%)	N/A	N/A	Flare Slope RT (%)	N/A
N/A	Flare Traversable LT?	N/A	N/A	Flare Traversable RT?	N/A
N/A	Landing Length (in)	N/A	N/A	DWS Provided?	N/A
N/A	Landing Width (in)	N/A	N/A	DWS Contrast?	N/A
N/A	Landing Slope (%)	N/A	N/A	DWS Length (in)	N/A
N/A	Landing X Slope (%)	N/A	N/A	DWS Full Width?	N/A
N/A	Landing Curb? (Y/N)	N/A	N/A	DWS Offset (in)	N/A
N/A	Shared Landing?	N/A			
N/A	Gutter Ponding?	N/A	N/A	Gutter Slope (%)	N/A
N/A	Gutter Lip Ht (in)	N/A	N/A	Gutter X Slope (%)	N/A
N/A	Painted X Walk1?	No	N/A	Painted X Walk2?	N/A
	X Walk 1 Direction	To W		X Walk 2 Direction	N/A
	X Walk 1 Width (in)	N/A		X Walk 2 Width (in)	N/A
	X Walk 1 Slope (%)	3.5		X Walk 2 Slope (%)	N/A
	X Walk 1 X Slope (%)	0.2		X Walk 2 X Slope (%)	N/A

N/A	Ramp inside XWalk1?	N/A	N/A	Ramp inside XWalk2?	N/A
	Road Slope (%)	0.2		Clear Space?	N/A
	Road X Slope (%)	3.5	N/A	Clear Space to XWalk (in)	N/A
N/A	Any Obstructions?	N/A	N/A	Storm Grate/Utility Hazard?	N/A
	Obstruction Type			Storm Grate/Utility Type	
		N/A			N/A
			Yes	Surface Condition? (G/P)	Good
			No	Curb Slope (%)	17.9

**Remove & Replace Curb Ramp With Two New Directional Ramps or Equivalent.**
