Access Compliance Report

Public Rights-of-Way

(Curb Ramps)

| Intersection ID: 50763 | Main Street: QUIET_CREEK_CR | Cross Street: SCOTT_CREEK_DR | Location: | N |

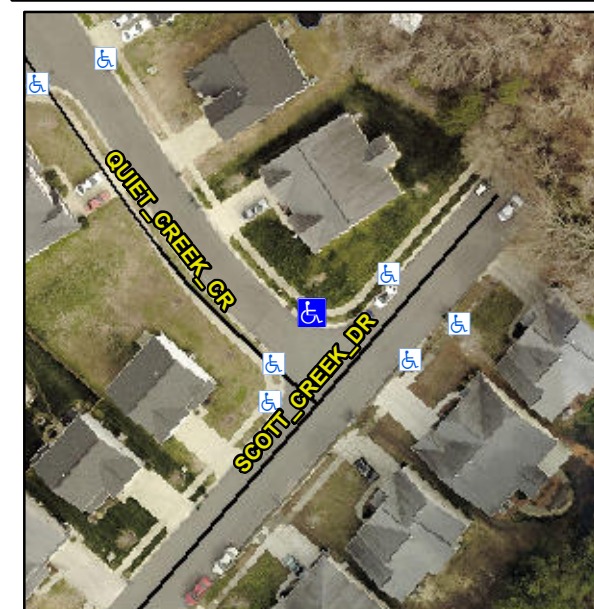
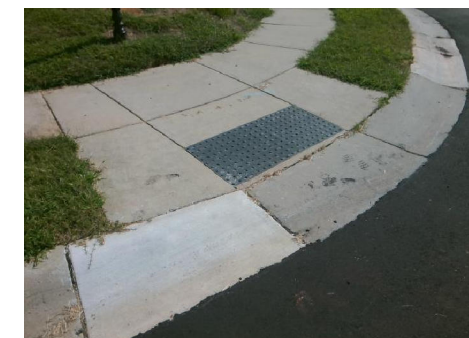
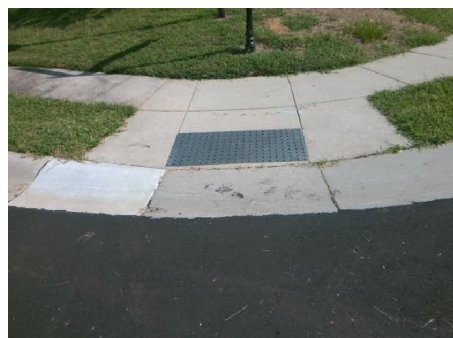
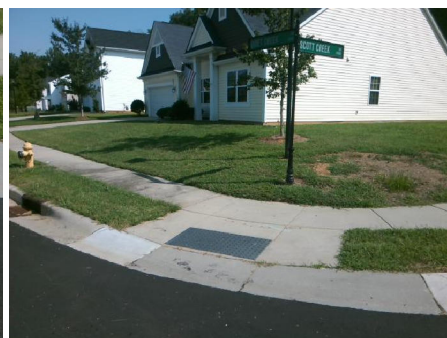
| ADA ID: 29896E7145A6 | Ramp Type: PerpDiag | Initial Pass/Fail: Fail | Overall Compliance: No | Severity Score: 8.75 |

Not Found, R304.5.1

| Compliance | Description | Data | Compliance | Description | Data |
|---|---|---|---|---|---|
| No | Ramp Width (in) | 47.5 | Yes | Ramp XSlope (%) | 1.7 |

Remove & Replace Curb Ramp With Two New Directional Ramps or Equivalent.
