Access Compliance Report Public Rights-of-Way (Curb Ramps)

Intersection ID: 52487 Main Street: WHITEHALL_EXECUTIVE_CENTERs DStreet: ORLICK_DR Location: N

Overall Compliance: No ADA ID: 298AE720981E Ramp Type: Perp Initial Pass/Fail: Fail **Severity Score:** 12.5

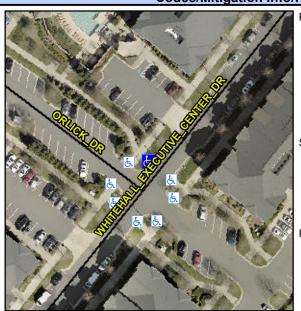
Field Measurements/Component Compliance								
Comp	liance Description	Data	Comp	liance	Description	Data		
N/A	Ramp Length (in)	56.0	No	Ram	Slope (%)	9.5		
Yes	Ramp Width (in)	70.0	Yes	Yes Ramp XSlope (%)		0.4		
N/A	Flare Type LT	N/A	N/A	N/A Flare Type RT		N/A		
N/A	Flare Slope LT (%)	N/A	N/A	N/A Flare Slope RT (%)		N/A		
N/A	Flare Traversable LT?	N/A	N/A	N/A Flare Traversable RT?		N/A		
N/A	Landing Length (in)	N/A	N/A	DWS Provided?		N/A		
N/A	Landing Width (in)	N/A	N/A	A DWS Contrast?		N/A		
N/A	Landing Slope (%)	N/A	N/A	DWS	Length (in)	N/A		
N/A	Landing X Slope (%)	N/A	N/A	DWS	Full Width?	N/A		
N/A	Landing Curb? (Y/N)	N/A	N/A	DWS	Offset (in)	N/A		
N/A	Shared Landing?	N/A						
N/A	Gutter Ponding?	N/A	N/A	Gutte	er Slope (%)	N/A		
N/A	Gutter Lip Ht (in)	N/A	N/A	Gutte	er X Slope (%)	N/A		
N/A	Painted X Walk1?	No	N/A	Paint	ed X Walk2?	N/A		
	X Walk 1 Direction	To SE		X Wa	lk 2 Direction	N/A		
N/A	X Walk 1 Width (in)	N/A	N/A	X Wa	lk 2 Width (in)	N/A

X Walk 1 Slope (%)	2.0		X Wa	lk 2 Slope (%)	N/A		
	X Walk 1 X Slope (%)	0.8		X Wa	lk 2 X Slope (%)	N/A		
N/A	Ramp inside XWalk1?	N/A	N/A	Ram	o inside XWalk2?	N/A		
	Road Slope (%)	N/A	N/A	Clear	Space?	N/A		
	Road X Slope (%)	N/A	N/A	Clear	Space to XWalk (in)	N/A		
N/A	Any Obstructions?	N/A	N/A	Storn	n Grate/Utility Hazard?	N/A		
	Obstruction Type			Storn	n Grate/Utility Type			
		N/A				N/A		
			Yes	Surfa	ce Condition? (G/P)	Good		
1

Possible Solutions:	<u>c</u>
Remove & Replace Entire Ramp.	N
	Υ
	N
	N
	N
	N
Surveyor Notes:	N
N/A	N
	N
	N
	N
PROW/ADA:	N
Not Found, R304.2.2	N
·	N
	N
	N
