Access Compliance Report

Public Rights-of-Way

(Curb Ramps)

Intersection ID: 29786	Main Street: ELM_LN	Cross Street: MILLWRIGHT_LN	Location: SW
ADA ID: 2990D37A47E9	Ramp Type: Perp	Initial Pass/Fail: Fail	Overall Compliance: No
Severity Score: 21.25			
Codes/Mitigation Info/Possible Solution		Field Measurements/Component Compliance

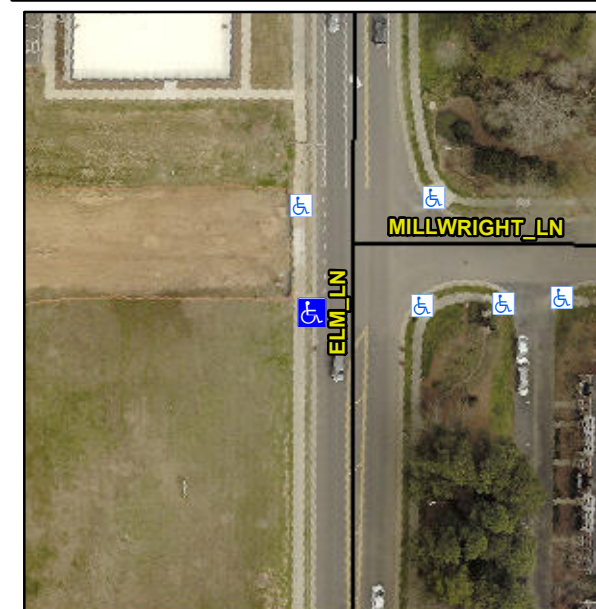
Not Found, R304.5.1, R304.2.2

Compliance	Description	Data	Compliance	Description	Data
N/A	Ramp Length (in)	79.0	No	Ramp Slope (%)	8.9
No	Ramp Width (in)	47.5	Yes	Ramp XSlope (%)	1.0
N/A	Flare Type LT	N/A	N/A	Flare Type RT	N/A
N/A	Flare Slope LT (%)	N/A	N/A	Flare Slope RT (%)	N/A
N/A	Flare Traversable LT?	N/A	N/A	Flare Traversable RT?	N/A
N/A	Landing Length (in)	N/A	N/A	DWS Provided?	N/A
N/A	Landing Width (in)	N/A	N/A	DWS Contrast?	N/A
N/A	Landing Slope (%)	N/A	N/A	DWS Length (in)	N/A
N/A	Landing X Slope (%)	N/A	N/A	DWS Full Width?	N/A
N/A	Landing Curb? (Y/N)	N/A	N/A	DWS Offset (in)	N/A
N/A	Shared Landing?	N/A			
N/A	Gutter Ponding?	N/A	N/A	Gutter Slope (%)	N/A
N/A	Gutter Lip Ht (in)	N/A	N/A	Gutter X Slope (%)	N/A
N/A	Painted X Walk1?	No	N/A	Painted X Walk2?	N/A
	X Walk 1 Direction	To SE		X Walk 2 Direction	N/A
N/A	X Walk 1 Width (in)	N/A	N/A	X Walk 2 Width (in)	N/A
	X Walk 1 Slope (%)	4.1		X Walk 2 Slope (%)	N/A
	X Walk 1 X Slope (%)	1.6		X Walk 2 X Slope (%)	N/A

N/A	Ramp inside XWalk1?	N/A	N/A	Ramp inside XWalk2?	N/A
	Road Slope (%)	N/A	N/A	Clear Space?	N/A
	Road X Slope (%)	N/A	N/A	Clear Space to XWalk (in)	N/A
N/A	Any Obstructions?	N/A	N/A	Storm Grate/Utility Hazard?	N/A
	Obstruction Type			Storm Grate/Utility Type	
		N/A			N/A
			Yes	Surface Condition? (G/P)	Good

Possible Solutions:

Remove & Replace Entire Ramp.

Total Cost: \$ 1850.00
