Access Compliance Report

Public Rights-of-Way

(Curb Ramps)

Intersection ID: 13228	Main Street: CENTRAL_AV	Cross Street: LANDIS_AV	Location:	S
ADA ID: 29918AD67B9A	Ramp Type: Perp	Initial Pass/Fail: Fail	Overall Compliance: No	Severity Score: 25

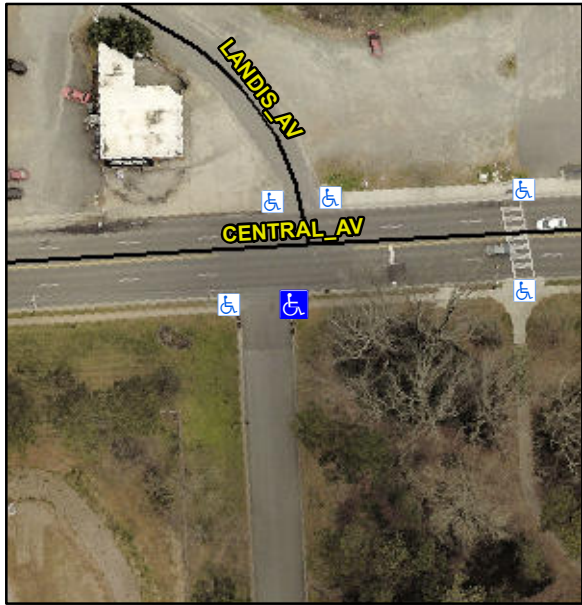
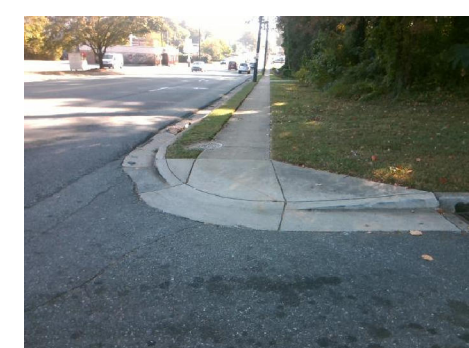
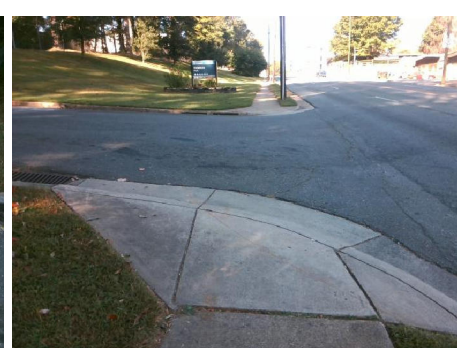
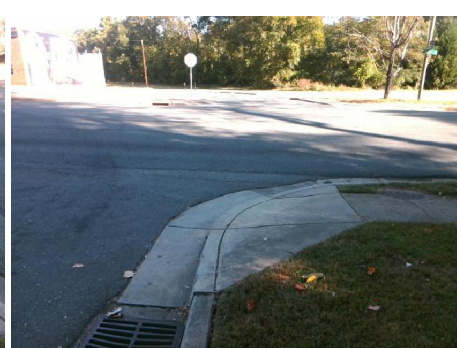
Possible Solutions:		Compliance	Description	Data	Compliance	Description	Data
	Remove & Replace Entire Ramp.		N/A	Ramp Length (in)	43.0	Yes	Ramp Slope (%)	5.0
			Yes	Ramp Width (in)	48.0	No	Ramp XSlope (%)	9.5
			N/A	Flare Type LT	N/A	N/A	Flare Type RT	N/A
			N/A	Flare Slope LT (%)	N/A	N/A	Flare Slope RT (%)	N/A
			N/A	Flare Traversable LT?	N/A	N/A	Flare Traversable RT?	N/A
			N/A	Landing Length (in)	N/A	N/A	DWS Provided?	N/A
			N/A	Landing Width (in)	N/A	N/A	DWS Contrast?	N/A
			N/A	Landing Slope (%)	N/A	N/A	DWS Length (in)	N/A
			N/A	Landing X Slope (%)	N/A	N/A	DWS Full Width?	N/A
Surveyor Notes:			N/A	Landing Curb? (Y/N)	N/A	N/A	DWS Offset (in)	N/A
PROW/ADA:			N/A	Shared Landing?	N/A			
Not Found, R304.5.3			N/A	Gutter Ponding?	N/A	N/A	Gutter Slope (%)	N/A
			N/A	Gutter Lip Ht (in)	N/A	N/A	Gutter X Slope (%)	N/A

N/A	Painted X Walk1?	No	N/A	Painted X Walk2?	N/A
				X Walk 1 Direction	To W		X Walk 2 Direction	N/A
			N/A	X Walk 1 Width (in)	N/A	N/A	X Walk 2 Width (in)	N/A
				X Walk 1 Slope (%)	8.8		X Walk 2 Slope (%)	N/A
				X Walk 1 X Slope (%)	3.5		X Walk 2 X Slope (%)	N/A
			N/A	Ramp inside XWalk1?	N/A	N/A	Ramp inside XWalk2?	N/A
				Road Slope (%)	N/A	N/A	Clear Space?	N/A
				Road X Slope (%)	N/A	N/A	Clear Space to XWalk (in)	N/A
			N/A	Any Obstructions?	N/A	N/A	Storm Grate/Utility Hazard?	N/A
				Obstruction Type			Storm Grate/Utility Type	
						N/A		N/A
						Yes	Surface Condition? (G/P)	Good
