Access Compliance Report

Public Rights-of-Way

(Curb Ramps)

Intersection ID: 42943	Main Street: LONG PAW LN	Cross Street: SONOMA VALLEY DR	Location: W
ADA ID: 299E2E560D55	Ramp Type: PerpDiag	Initial Pass/Fail: Fail	Overall Compliance: No
		Severity Score: 10

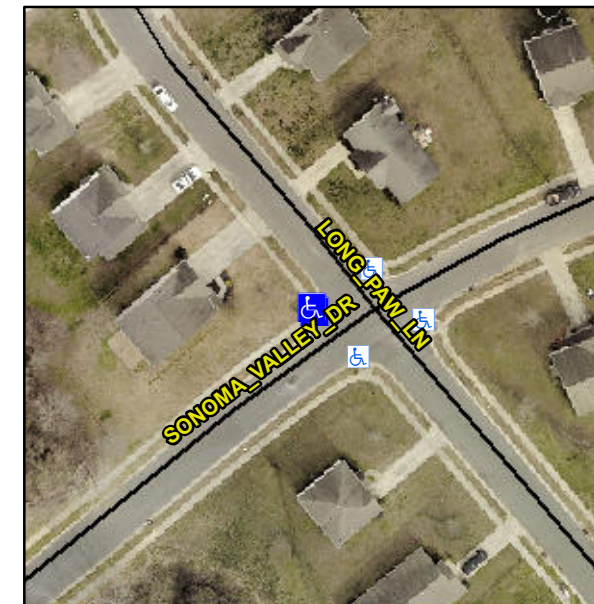
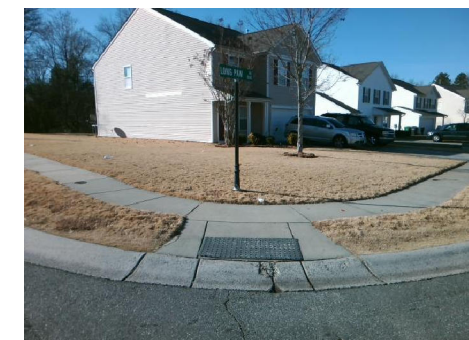
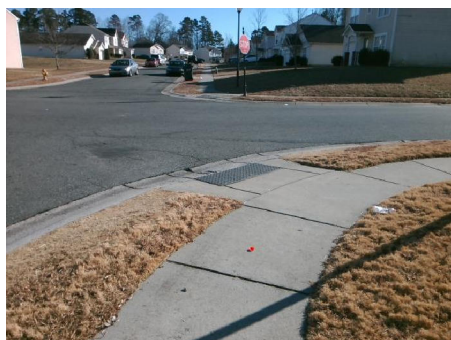
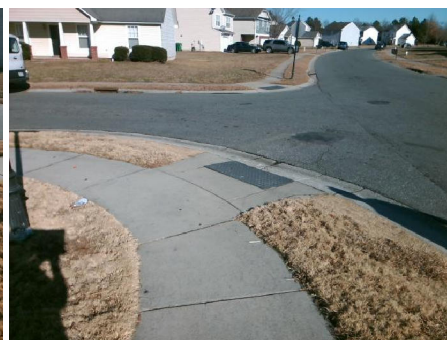
Compliance	Description	Data	Compliance	Description	Data
N/A	Ramp Length (in)	49.0	Yes	Ramp Slope (%)	7.1
No	Ramp Width (in)	47.0	No	Ramp XSlope (%)	2.6
N/A	Flare Type LT	N/A	N/A	Flare Type RT	N/A
N/A	Flare Slope LT (%)	N/A	N/A	Flare Slope RT (%)	N/A
N/A	Flare Traversable LT?	N/A	N/A	Flare Traversable RT?	N/A
N/A	Landing Length (in)	N/A	N/A	DWS Provided?	N/A
N/A	Landing Width (in)	N/A	N/A	DWS Contrast?	N/A
N/A	Landing Slope (%)	N/A	N/A	DWS Length (in)	N/A
N/A	Landing X Slope (%)	N/A	N/A	DWS Full Width?	N/A
N/A	Landing Curb? (Y/N)	N/A	N/A	DWS Offset (in)	N/A
N/A	Shared Landing?	N/A			
N/A	Gutter Ponding?	N/A	N/A	Gutter Slope (%)	N/A
N/A	Gutter Lip Ht (in)	N/A	N/A	Gutter X Slope (%)	N/A
N/A	Painted X Walk1?	No	N/A	Painted X Walk2?	No
	X Walk 1 Direction	To SE		X Walk 2 Direction	To NE
N/A	X Walk 1 Width (in)	N/A	N/A	X Walk 2 Width (in)	N/A
	X Walk 1 Slope (%)	4.9		X Walk 2 Slope (%)	2.1
	X Walk 1 X Slope (%)	0.9		X Walk 2 X Slope (%)	3.7

N/A	Ramp inside XWalk1?	N/A	N/A	Ramp inside XWalk2?	N/A
	Road Slope (%)	3.9	N/A	Clear Space?	N/A
	Road X Slope (%)	3.9	N/A	Clear Space to XWalk (in)	N/A
N/A	Any Obstructions?	N/A	N/A	Storm Grate/Utility Hazard?	N/A
	Obstruction Type			Storm Grate/Utility Type	
		N/A			N/A
			Yes	Surface Condition? (G/P)	Good

Remove & Replace Curb Ramp With Two New Directional Ramps or Equivalent.

Not Found, R304.5.1, R304.5.3
