# Access Compliance Report

## Public Rights-of-Way

### (Curb Ramps)

| Intersection ID: 43358 | Main Street: PROSPERITY COMMONS DR | Cross Street: ROCKY FORD CLUB RD | Location: SW |

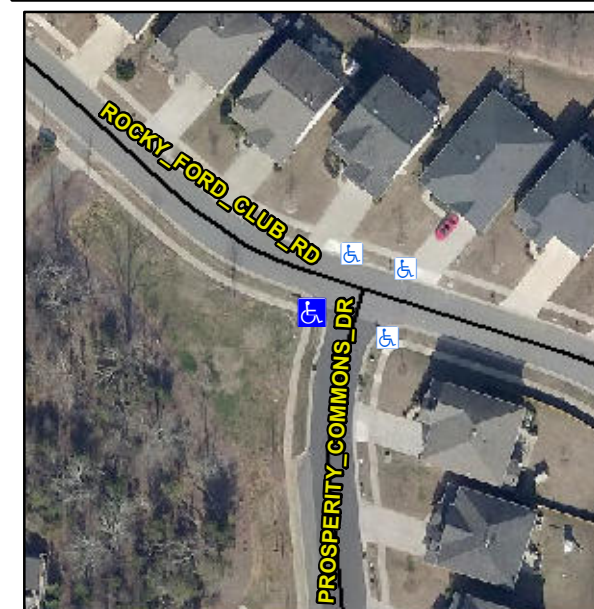
| ADA ID: 29A41E69E59C | Ramp Type: BlendTrans1 | Initial Pass/Fail: Fail | Overall Compliance: No |
| Severity Score: 10 | | | |

**R304.5.1, R304.5.3**

| Compliance | Description | Data | Compliance | Description | Data |
|---|---|---|---|---|---|
| No | Ramp Width (in) | 42.5 | No | BlendTrans XSlope (%) | 3.7 |

**Remove & Replace Curb Ramp With Two New Directional Ramps or Equivalent.**

Total Cost: \$ 3200.00
