Access Compliance Report

Public Rights-of-Way

(Curb Ramps)

Intersection ID: 45787	Main Street: COPPER_TOP_CT	Cross Street: LONG_HILL_DR	Location: SE
ADA ID: 29BEF26B74C7	Ramp Type: BlendTrans1	Initial Pass/Fail: Fail	Overall Compliance: No
Severity Score: 8.75			
Codes/Mitigation Info/Possible Solution		Field Measurements/Component Compliance

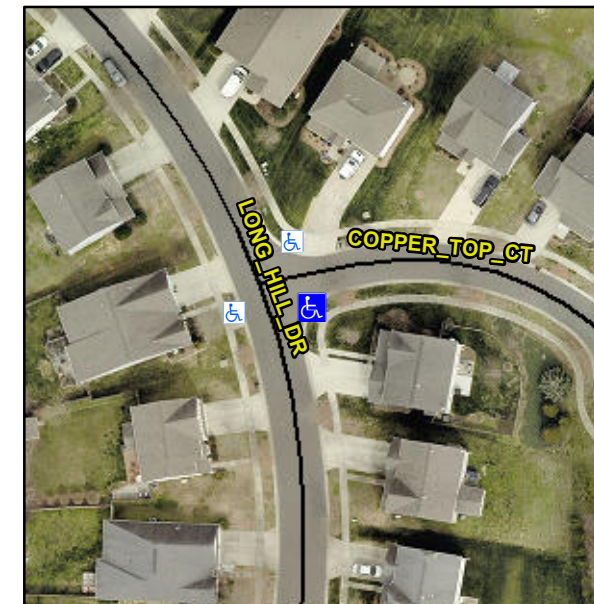
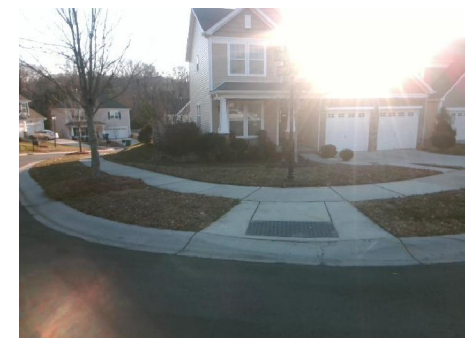
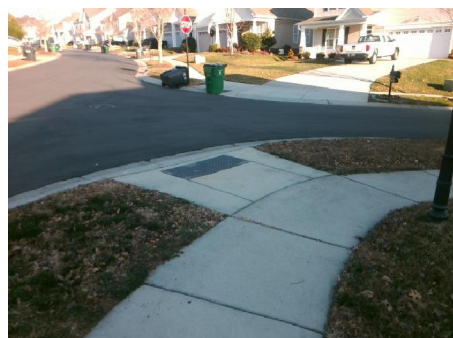
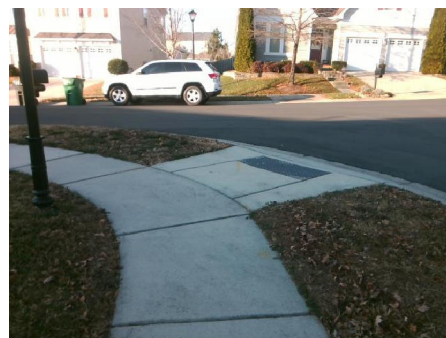
Not Found, R304.5.1

Compliance	Description	Data	Compliance	Description	Data
N/A	Ramp Length (in)	72.0	Yes	BlendTrans Slope (%)	2.1
No	Ramp Width (in)	45.0	Yes	BlendTrans XSlope (%)	0.9
N/A	Flare Type LT	N/A	N/A	Flare Type RT	N/A
N/A	Flare Slope LT (%)	N/A	N/A	Flare Slope RT (%)	N/A
N/A	Flare Traversable LT?	N/A	N/A	Flare Traversable RT?	N/A
N/A	Landing Length (in)	N/A	N/A	DWS Provided?	N/A
N/A	Landing Width (in)	N/A	N/A	DWS Contrast?	N/A
N/A	Landing Slope (%)	N/A	N/A	DWS Length (in)	N/A
N/A	Landing X Slope (%)	N/A	N/A	DWS Full Width?	N/A
N/A	Landing Curb? (Y/N)	N/A	N/A	DWS Offset (in)	N/A
N/A	Shared Landing?	N/A			
N/A	Gutter Ponding?	N/A	N/A	Gutter Slope (%)	N/A
N/A	Gutter Lip Ht (in)	N/A	N/A	Gutter X Slope (%)	N/A
N/A	Painted X Walk1?	No	N/A	Painted X Walk2?	No
	X Walk 1 Direction	To N		X Walk 2 Direction	To W
	X Walk 1 Width (in)	N/A		X Walk 2 Width (in)	N/A
	X Walk 1 Slope (%)	4.4		X Walk 2 Slope (%)	4.1
	X Walk 1 X Slope (%)	3.9		X Walk 2 X Slope (%)	2.9

N/A	Ramp inside XWalk1?	N/A	N/A	Ramp inside XWalk2?	N/A
	Road Slope (%)	0.2		Clear Space?	N/A
	Road X Slope (%)	6.1	N/A	Clear Space to XWalk (in)	N/A
N/A	Any Obstructions?	N/A	N/A	Storm Grate/Utility Hazard?	N/A
	Obstruction Type			Storm Grate/Utility Type	
		N/A			N/A
			Yes	Surface Condition? (G/P)	Good
			No	Curb Slope (%)	22.2

Possible Solutions:

Remove & Replace Curb Ramp With Two New Directional Ramps or Equivalent.
