Access Compliance Report Public Rights-of-Way (Curb Ramps)

Intersection ID: N/A Main Street: PINEVILLE-MATTHEWS RD **Cross Street: N/A** Location: SW ADA ID: 29C596A356F6 Ramp Type: PerpDiag Initial Pass/Fail: Fail **Overall Compliance: No Severity Score:** 50

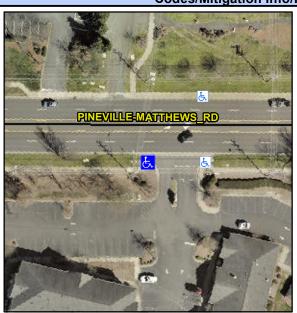
Field Measurements/Component Compliance					
Compliance Description		Data	Comp	liance Description	Data
N/A	Ramp Length (in)	98.0	No	Ramp Slope (%)	12.8
Yes	Ramp Width (in)	59.0	No	Ramp XSlope (%)	9.6
N/A	Flare Type LT	N/A	N/A	Flare Type RT	N/A
N/A	Flare Slope LT (%)	N/A	N/A	Flare Slope RT (%)	N/A
N/A	Flare Traversable LT?	N/A	N/A	Flare Traversable RT?	N/A
N/A	Landing Length (in)	N/A	N/A	DWS Provided?	N/A
N/A	Landing Width (in)	N/A	N/A	DWS Contrast?	N/A
N/A	Landing Slope (%)	N/A	N/A	DWS Length (in)	N/A
N/A	Landing X Slope (%)	N/A	N/A	DWS Full Width?	N/A
N/A	Landing Curb? (Y/N)	N/A	N/A	DWS Offset (in)	N/A
N/A	Shared Landing?	N/A			
N/A	Gutter Ponding?	N/A	N/A	Gutter Slope (%)	N/A
N/A	Gutter Lip Ht (in)	N/A	N/A	Gutter X Slope (%)	N/A
N/A	Painted X Walk1?	No	N/A	Painted X Walk2?	No
	X Walk 1 Direction	To E		X Walk 2 Direction	To N
N/A	X Walk 1 Width (in)	N/A	N/A	X Walk 2 Width (in)	N/A
	X Walk 1 Slope (%)	4.9		X Walk 2 Slope (%)	3.3

X Walk 1 X Slope (%)	6.1		X Walk 2 X Slope (%)	0.4
N/A	Ramp inside XWalk1?	N/A	N/A	Ramp inside XWalk2?	N/A
	Road Slope (%)	0.8	N/A	Clear Space?	N/A
	Road X Slope (%)	3.5	N/A	Clear Space to XWalk (in)	N/A
N/A	Any Obstructions?	N/A	N/A	Storm Grate/Utility Hazard?	N/A
	Obstruction Type		l	Storm Grate/Utility Type	
		N/A			N/A
			Yes	Surface Condition? (G/P)	Good

Possible Solutions: Remove & Replace Curb Ramp With Two New Directional Ramps or Equivalent. Surveyor Notes: N/A PROW/ADA: R304.2.2, R304.5.3
