Access Compliance Report

Public Rights-of-Way

(Curb Ramps)

Intersection ID: 10034564	Main Street: PINEY GROVE RD	Cross Street: N/A	Location:	E
ADA ID: 29C85400F9B0	Ramp Type: Perp	Initial Pass/Fail: Pass	Overall Compliance: No	Severity Score: 20
Codes/Mitigation Info/Possible Solution		Field Measurements/Component Compliance

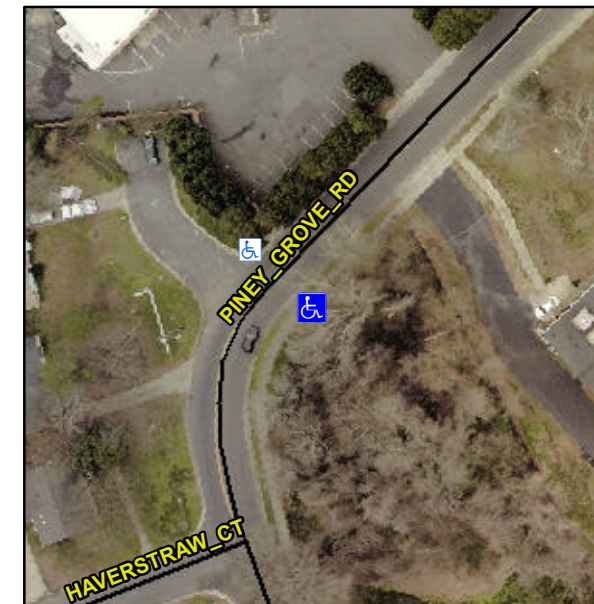
Compliance	Description	Data	Compliance	Description	Data
N/A	Ramp Length (in)	108.0	Yes	Ramp Slope (%)	5.8
Yes	Ramp Width (in)	51.0	Yes	Ramp XSlope (%)	0.3
N/A	Flare Type LT	Sloped	N/A	Flare Type RT	N/A
N/A	Flare Slope LT (%)	4.2	Yes	Flare Slope RT (%)	4.7
N/A	Flare Traversable LT?	Yes	N/A	Flare Traversable RT?	Yes
No	Landing Length (in)	N/A	No	DWS Provided?	No
No	Landing Width (in)	N/A	N/A	DWS Contrast?	No
No	Landing Slope (%)	N/A	N/A	DWS Length (in)	N/A
No	Landing X Slope (%)	N/A	N/A	DWS Full Width?	No
N/A	Landing Curb? (Y/N)	No	N/A	DWS Offset (in)	N/A
N/A	Shared Landing?	No			
Yes	Gutter Ponding?	No	Yes	Gutter Slope (%)	2.7
Yes	Gutter Lip Ht (in)	0.0	Yes	Gutter X Slope (%)	0.5
N/A	Painted X Walk1?	No	N/A	Painted X Walk2?	N/A
	X Walk 1 Direction	To NW		X Walk 2 Direction	N/A
N/A	X Walk 1 Width (in)	N/A	N/A	X Walk 2 Width (in)	N/A
	X Walk 1 Slope (%)	5.8		X Walk 2 Slope (%)	N/A
	X Walk 1 X Slope (%)	0.7		X Walk 2 X Slope (%)	N/A

N/A	Ramp inside XWalk1?	N/A	N/A	Ramp inside XWalk2?	N/A
	Road Slope (%)	N/A	N/A	Clear Space?	Yes
	Road X Slope (%)	N/A	N/A	Clear Space to XWalk (in)	N/A
Yes	Any Obstructions?	No	Yes	Storm Grate/Utility Hazard?	No
	Obstruction Type			Storm Grate/Utility Type	
		N/A			N/A
			Yes	Surface Condition? (G/P)	Good

Possible Solutions:

Remove & Replace Entire Ramp.

R304.2.1, R304.2.2-Perp, R304.3.2-Para, R304.5.3, R305

Total Cost: \$ 1850.00

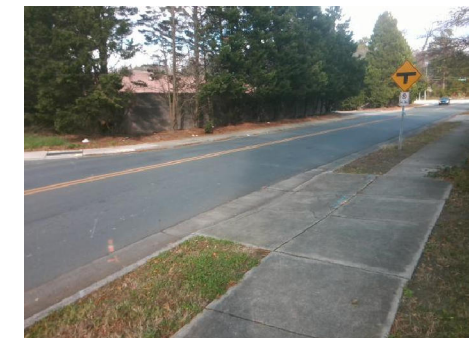
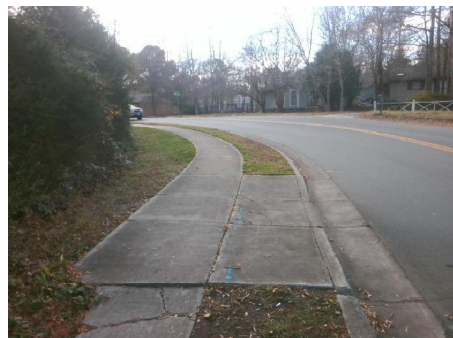
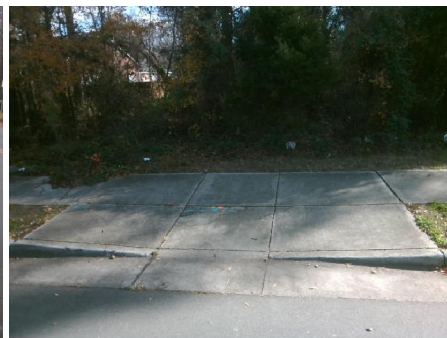
Street 1 Name	PINEY GROVE RD
Stop Condition-Street 2	None
Street 2 Name	N/A
Stop Condition-Street 1	N/A
