Access Compliance Report

Public Rights-of-Way

(Curb Ramps)

Intersection ID: N/A	Main Street: RIDGE_OAK_DR	Cross Street: CAROLINA_CROSSING_DR	Location: NW
ADA ID: 29CCDA1A4392	Ramp Type: Perp	Initial Pass/Fail: Fail	Overall Compliance: No
Severity Score: 37.5			
Codes/Mitigation Info/Possible Solution		Field Measurements/Component Compliance

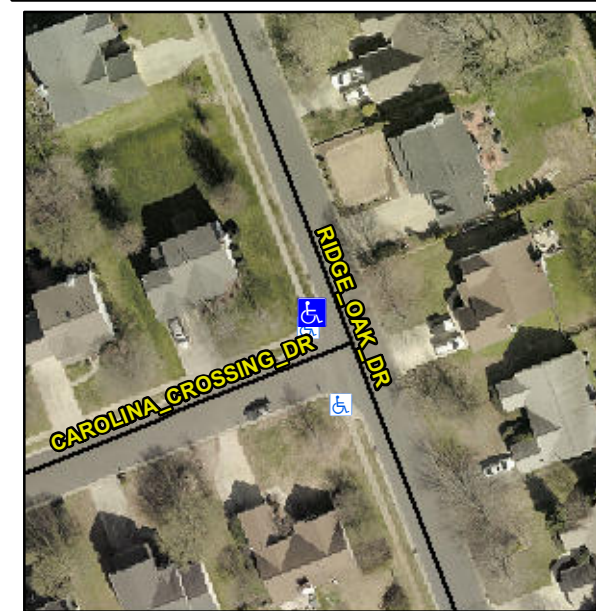
Compliance	Description	Data	Compliance	Description	Data
N/A	Ramp Length (in)	92.0	No	Ramp Slope (%)	9.2
No	Ramp Width (in)	43.0	No	Ramp XSlope (%)	2.9
N/A	Flare Type LT	N/A	N/A	Flare Type RT	N/A
N/A	Flare Slope LT (%)	N/A	N/A	Flare Slope RT (%)	N/A
N/A	Flare Traversable LT?	N/A	N/A	Flare Traversable RT?	N/A
N/A	Landing Length (in)	N/A	N/A	DWS Provided?	N/A
N/A	Landing Width (in)	N/A	N/A	DWS Contrast?	N/A
N/A	Landing Slope (%)	N/A	N/A	DWS Length (in)	N/A
N/A	Landing X Slope (%)	N/A	N/A	DWS Full Width?	N/A
N/A	Landing Curb? (Y/N)	N/A	N/A	DWS Offset (in)	N/A
N/A	Shared Landing?	N/A			
N/A	Gutter Ponding?	N/A	N/A	Gutter Slope (%)	N/A
N/A	Gutter Lip Ht (in)	N/A	N/A	Gutter X Slope (%)	N/A
N/A	Painted X Walk1?	No	N/A	Painted X Walk2?	N/A
	X Walk 1 Direction	To NE		X Walk 2 Direction	N/A
N/A	X Walk 1 Width (in)	N/A	N/A	X Walk 2 Width (in)	N/A
	X Walk 1 Slope (%)	2.8		X Walk 2 Slope (%)	N/A
	X Walk 1 X Slope (%)	0.5		X Walk 2 X Slope (%)	N/A

N/A	Ramp inside XWalk1?	N/A	N/A	Ramp inside XWalk2?	N/A
	Road Slope (%)	N/A	N/A	Clear Space?	N/A
	Road X Slope (%)	N/A	N/A	Clear Space to XWalk (in)	N/A
N/A	Any Obstructions?	N/A	N/A	Storm Grate/Utility Hazard?	N/A
	Obstruction Type			Storm Grate/Utility Type	
		N/A			N/A
		No		Surface Condition? (G/P)	Poor

Possible Solutions:

Remove & Replace Entire Ramp.

R304.5.1, R304.2.2, R304.5.3, R302.7

Total Cost: \$ 1850.00
