Access Compliance Report Public Rights-of-Way (Curb Ramps)

Intersection ID: 10032880Main Street: NATIONS_FORD_RDCross Street: N/ALocation:NEADA ID: 29CCE050DA36Ramp Type: ParaDiagInitial Pass/Fail: FailOverall Compliance: NoSeverity Score: 26.25

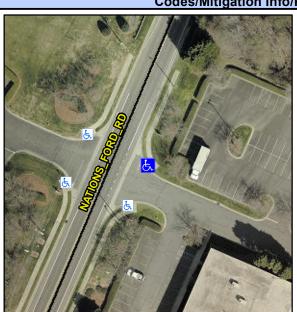
Field Measurements/Component Compliance					
Compliance Description		Data	Compliance Description		Data
N/A	Ramp Length LT (in)	55.0	N/A	Ramp Length RT (in)	59.0
Yes	Ramp Width LT (in)	107.0	Yes	Ramp Width RT (in)	107.0
Yes	Ramp Slope LT (%)	2.2	No	Ramp Slope RT (%)	12.1
Yes	Ramp XSlope LT (%)	1.9	No	Ramp XSlope RT (%)	3.0
N/A	Landing Length (in)	N/A	N/A	DWS Provided?	N/A
N/A	Landing Width (in)	N/A	N/A	DWS Contrast?	N/A
N/A	Landing Slope (%)	N/A	N/A	DWS Length (in)	N/A
N/A	Landing X Slope (%)	N/A	N/A	DWS Full Width?	N/A
N/A	Landing Curb? (Y/N)	N/A	N/A	DWS Offset (in)	N/A
N/A	Shared Landing?	N/A			
N/A	Gutter Ponding?	N/A	N/A	Gutter Slope (%)	N/A
N/A	Gutter Lip Ht (in)	N/A	N/A	Gutter X Slope (%)	N/A
N/A	Painted X Walk1?	No	N/A	Painted X Walk2?	No
	X Walk 1 Direction	To NW		X Walk 2 Direction	To SW
N/A	X Walk 1 Width (in)	N/A	N/A	X Walk 2 Width (in)	N/A
	X Walk 1 Slope (%)	1.5		X Walk 2 Slope (%)	8.6
	X Walk 1 X Slope (%)	6.3		X Walk 2 X Slope (%)	1.2

N/A	Ramp inside XWalk1?	N/A	N/A	Ramp inside XWalk2?	N/A
	Road Slope (%)	5.8	N/A	Clear Space?	N/A
	Road X Slope (%)	5.4	N/A	Clear Space to XWalk (in)	N/A
N/A	Any Obstructions?	N/A	N/A	Storm Grate/Utility Hazard?	N/A
	Obstruction Type			Storm Grate/Utility Type

• •	N/A			N/A
			Yes	Surface Condition? (G/P)	Good
			N/A	Curb Slope (%)	7.8
			•	1 ()

Possible Solutions:

Remove & Replace Curb Ramp With Two New Directional Ramps or Equivalent.

R304.3.2, R304.5.3
