Access Compliance Report

Public Rights-of-Way

(Curb Ramps)

Intersection ID: 4026	Main Street: CLAYBROOKE_DR	Cross Street: GALLOWAY_RD	Location: SE
ADA ID: 29CD70F9A5FC	Ramp Type: Perp	Initial Pass/Fail: Fail	Overall Compliance: No
Severity Score: 12.5			
Codes/Mitigation Info/Possible Solution		Field Measurements/Component Compliance

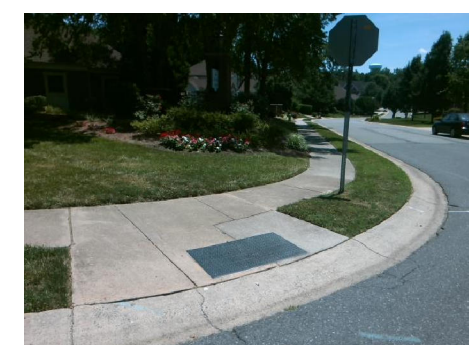
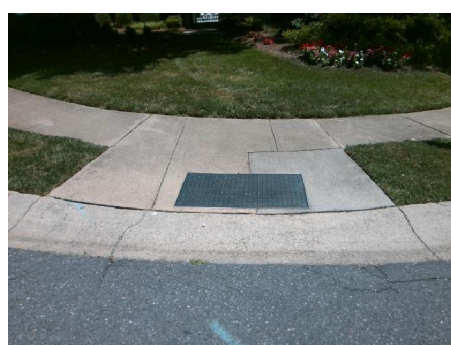
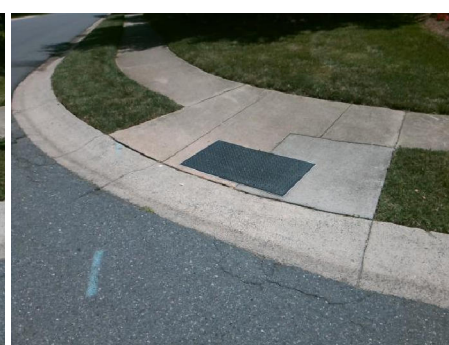
Not Found, R304.5.3

Compliance	Description	Data	Compliance	Description	Data
N/A	Ramp Length (in)	49.5	Yes	Ramp Slope (%)	6.2
Yes	Ramp Width (in)	48.0	No	Ramp XSlope (%)	6.4
N/A	Flare Type LT	N/A	N/A	Flare Type RT	N/A
N/A	Flare Slope LT (%)	N/A	N/A	Flare Slope RT (%)	N/A
N/A	Flare Traversable LT?	N/A	N/A	Flare Traversable RT?	N/A
N/A	Landing Length (in)	N/A	N/A	DWS Provided?	N/A
N/A	Landing Width (in)	N/A	N/A	DWS Contrast?	N/A
N/A	Landing Slope (%)	N/A	N/A	DWS Length (in)	N/A
N/A	Landing X Slope (%)	N/A	N/A	DWS Full Width?	N/A
N/A	Landing Curb? (Y/N)	N/A	N/A	DWS Offset (in)	N/A
N/A	Shared Landing?	N/A			
N/A	Gutter Ponding?	N/A	N/A	Gutter Slope (%)	N/A
N/A	Gutter Lip Ht (in)	N/A	N/A	Gutter X Slope (%)	N/A
N/A	Painted X Walk1?	No	N/A	Painted X Walk2?	N/A
	X Walk 1 Direction	To W		X Walk 2 Direction	N/A
N/A	X Walk 1 Width (in)	N/A	N/A	X Walk 2 Width (in)	N/A
	X Walk 1 Slope (%)	2.8		X Walk 2 Slope (%)	N/A
	X Walk 1 X Slope (%)	5.5		X Walk 2 X Slope (%)	N/A

N/A	Ramp inside XWalk1?	N/A	N/A	Ramp inside XWalk2?	N/A
	Road Slope (%)	N/A	N/A	Clear Space?	N/A
	Road X Slope (%)	N/A	N/A	Clear Space to XWalk (in)	N/A
N/A	Any Obstructions?	N/A	N/A	Storm Grate/Utility Hazard?	N/A
	Obstruction Type			Storm Grate/Utility Type	
		N/A			N/A
		Yes		Surface Condition? (G/P)	Good

Remove & Replace Entire Ramp.

Total Cost: \$ 1850.00
