Access Compliance Report

Public Rights-of-Way

(Curb Ramps)

Intersection ID: 52443	Main Street: WILLOW_GREEN_PL	Cross Street: BENDING_BIRCH_PL	Location: NW
ADA ID: 29D36346A14C	Ramp Type: Directional1	Initial Pass/Fail: Fail	Overall Compliance: No
			Severity Score: 13.75

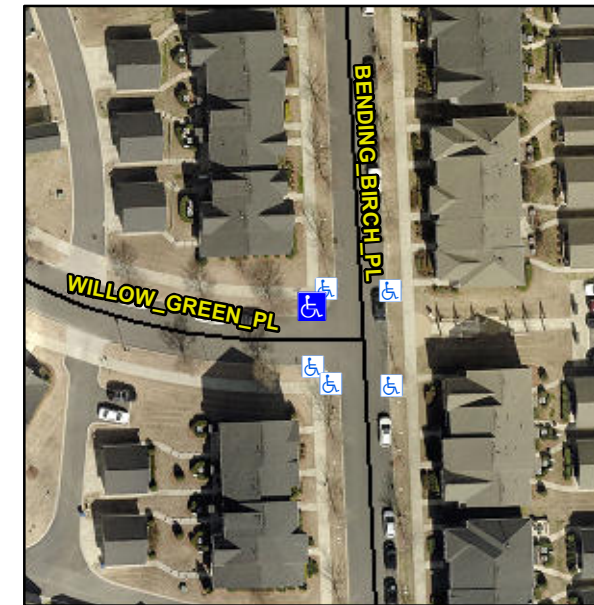
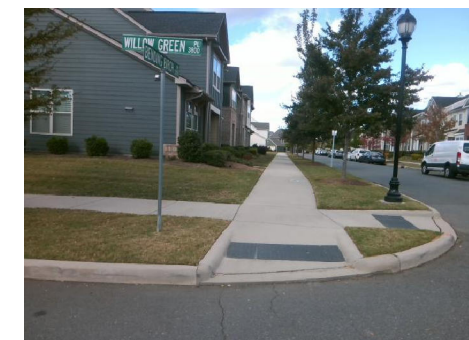
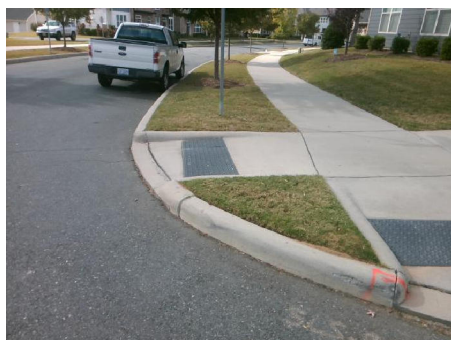
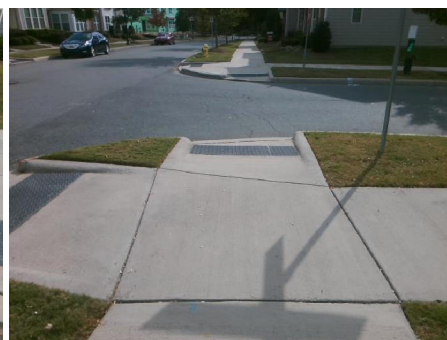
Compliance	Description	Data	Compliance	Description	Data
N/A	Ramp Length (in)	62.5	N/A	Grade Break?	N/A
Yes	Ramp Width (in)	63.0	N/A	Grade Break Slope (%)	0.0
No	Ramp Slope (%)	11.1	N/A	Grade Break XSlope (%)	0.0
No	Ramp XSlope (%)	2.4			
N/A	Flare Type LT	N/A	N/A	Flare Type RT	N/A
N/A	Flare Slope LT (%)	N/A	N/A	Flare Slope RT (%)	0.0
N/A	Flare Traversable LT?	N/A	N/A	Flare Traversable RT?	N/A
N/A	Landing Length (in)	0.0	N/A	DWS Provided?	N/A
N/A	Landing Width (in)	0.0	N/A	DWS Contrast?	N/A
N/A	Landing Slope (%)	0.0	N/A	DWS Length (in)	N/A
N/A	Landing X Slope (%)	0.0	N/A	DWS Full Width?	N/A
N/A	Landing Curb? (Y/N)	N/A	N/A	DWS Offset LT (in)	N/A
N/A	Shared Landing?	N/A	N/A	DWS Offset RT (in)	N/A
N/A	Gutter Ponding?	0.0	N/A	Gutter Slope (%)	N/A
N/A	Gutter Lip Ht (in)	0.0	N/A	Gutter X Slope (%)	N/A
N/A	Painted X Walk1?	No		Road Slope (%)	0.2
	X Walk 1 Direction	To S		Road X Slope (%)	2.7
	X Walk 1 Width (in)	N/A		Clear Space?	N/A

X Walk 1 Slope (%)	0.2	N/A	Clear Space to XWalk (in)	N/A
	X Walk 1 X Slope (%)	2.7	N/A	Storm Grate/Utility Hazard?	N/A
N/A	Ramp inside XWalk1?	N/A		Storm Grate/Utility Type	
N/A	Any Obstructions?	N/A			N/A
	Obstruction Type		Yes	Surface Condition? (G/P)	Good
			N/A	Curb Slope (%)	7.9

Remove & Replace Entire Ramp.
