Access Compliance Report

Public Rights-of-Way

(Curb Ramps)

Intersection ID: 8672	Main Street: BENNETT_ST	Cross Street: HILLSBORO_AV	Location: NE
ADA ID: 29D83B8A9641	Ramp Type: BlendTrans1	Initial Pass/Fail: Fail	Overall Compliance: No
		Severity Score: 8.75

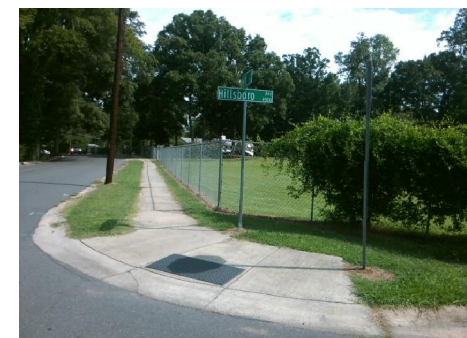
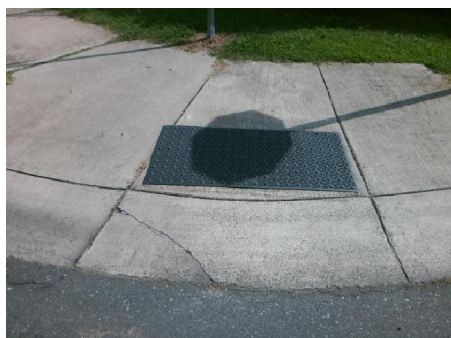
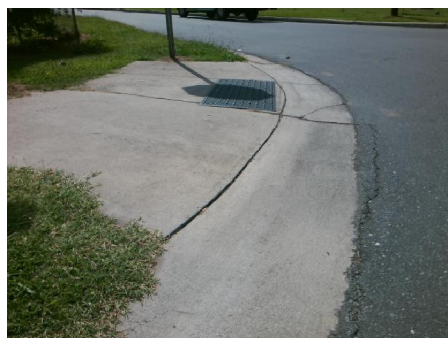
Possible Solutions:		Compliance	Description	Data	Compliance	Description	Data
	Remove & Replace Curb Ramp With Two New Directional Ramps or Equivalent.		N/A	Ramp Length (in)	78.5	Yes	BlendTrans Slope (%)	2.7
			No	Ramp Width (in)	36.0	Yes	BlendTrans XSlope (%)	0.6
			N/A	Flare Type LT	N/A	N/A	Flare Type RT	N/A
			N/A	Flare Slope LT (%)	N/A	N/A	Flare Slope RT (%)	N/A
			N/A	Flare Traversable LT?	N/A	N/A	Flare Traversable RT?	N/A
			N/A	Landing Length (in)	N/A	N/A	DWS Provided?	N/A
			N/A	Landing Width (in)	N/A	N/A	DWS Contrast?	N/A
			N/A	Landing Slope (%)	N/A	N/A	DWS Length (in)	N/A
			N/A	Landing X Slope (%)	N/A	N/A	DWS Full Width?	N/A
<p>Surveyor Notes:</p> <p>NO RT SW</p> <p>PROW/ADA:</p> <p>Not Found, R304.5.1</p>			N/A	Landing Curb? (Y/N)	N/A	N/A	DWS Offset (in)	N/A
			N/A	Shared Landing?	N/A			
			N/A	Gutter Ponding?	N/A	N/A	Gutter Slope (%)	N/A

N/A	Gutter Lip Ht (in)	N/A	N/A	Gutter X Slope (%)	N/A
			N/A	Painted X Walk1?	No	N/A	Painted X Walk2?	N/A
				X Walk 1 Direction	To S		X Walk 2 Direction	N/A
				X Walk 1 Width (in)	N/A		X Walk 2 Width (in)	N/A
				X Walk 1 Slope (%)	3.3		X Walk 2 Slope (%)	N/A
				X Walk 1 X Slope (%)	2.2		X Walk 2 X Slope (%)	N/A
			N/A	Ramp inside XWalk1?	N/A	N/A	Ramp inside XWalk2?	N/A
			Road Slope (%)	2.2		Clear Space?	N/A	
			Road X Slope (%)	3.3	N/A	Clear Space to XWalk (in)	N/A	
		N/A	Any Obstructions?	N/A	N/A	Storm Grate/Utility Hazard?	N/A	
			Obstruction Type			Storm Grate/Utility Type		
					N/A			N/A
						Yes	Surface Condition? (G/P)	Good
						No	Curb Slope (%)	17.4
